***PWB defects on Overhaul & Repair assemblies  
Analysis and Variances to J-STD-001 & IPC-A-610***

**Aaron Dermarderosian**  
Senior Principal General Engineer  
Engineering Services, Failure Analysis

04/27/2023 13:45-14:10

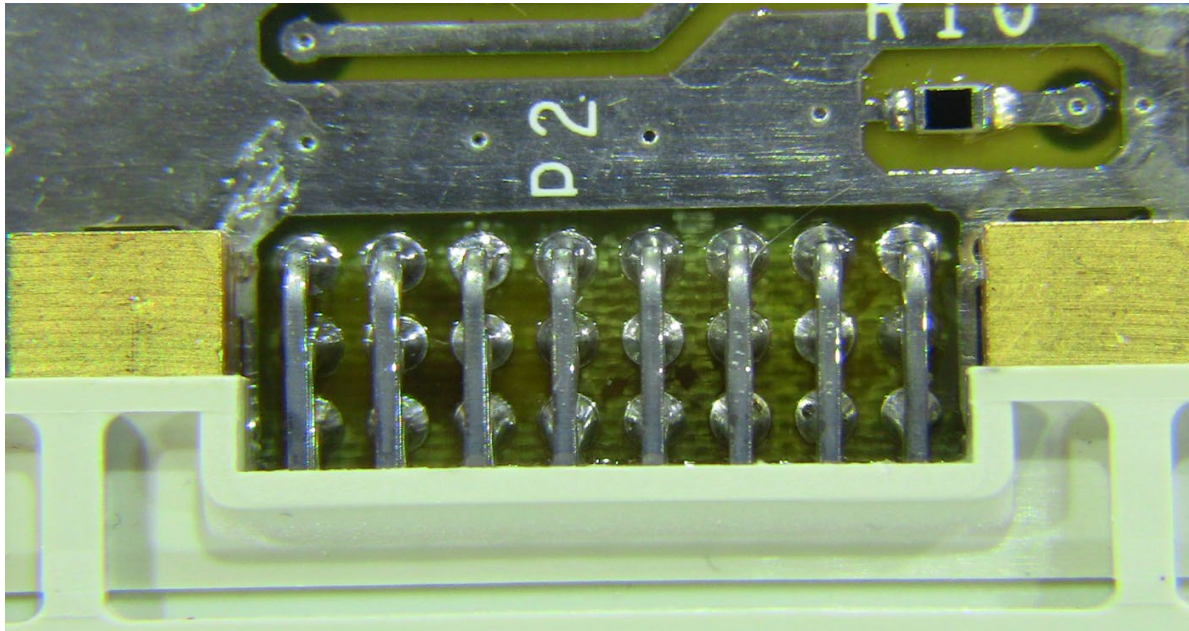
**P2 Connector Front side- Fiberglass separation**

**PWB substrate- Signs of heat stress & Internal blistered/separated fiberglass reinforcement from rework**

**Recommend:** CCA bake out and the addition of an environmental barrier coating to mitigate moisture / contaminant ingress around the affected RF connectors

Review Findings and Recommendations at Customer MRB, use CCA "AS IS"

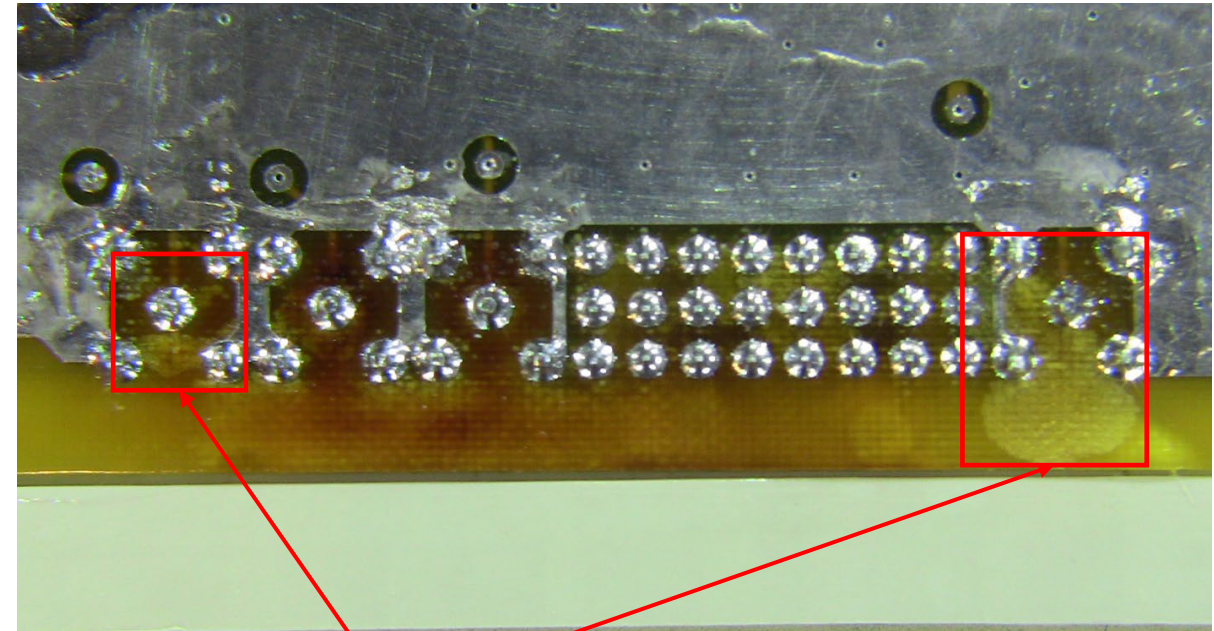
**P2 Connector Backside- Discoloration / Blistering**

- Adjacent RF connectors outside the damage area, are discolored
- Two RF connectors show delamination / blistering on the PWB backside

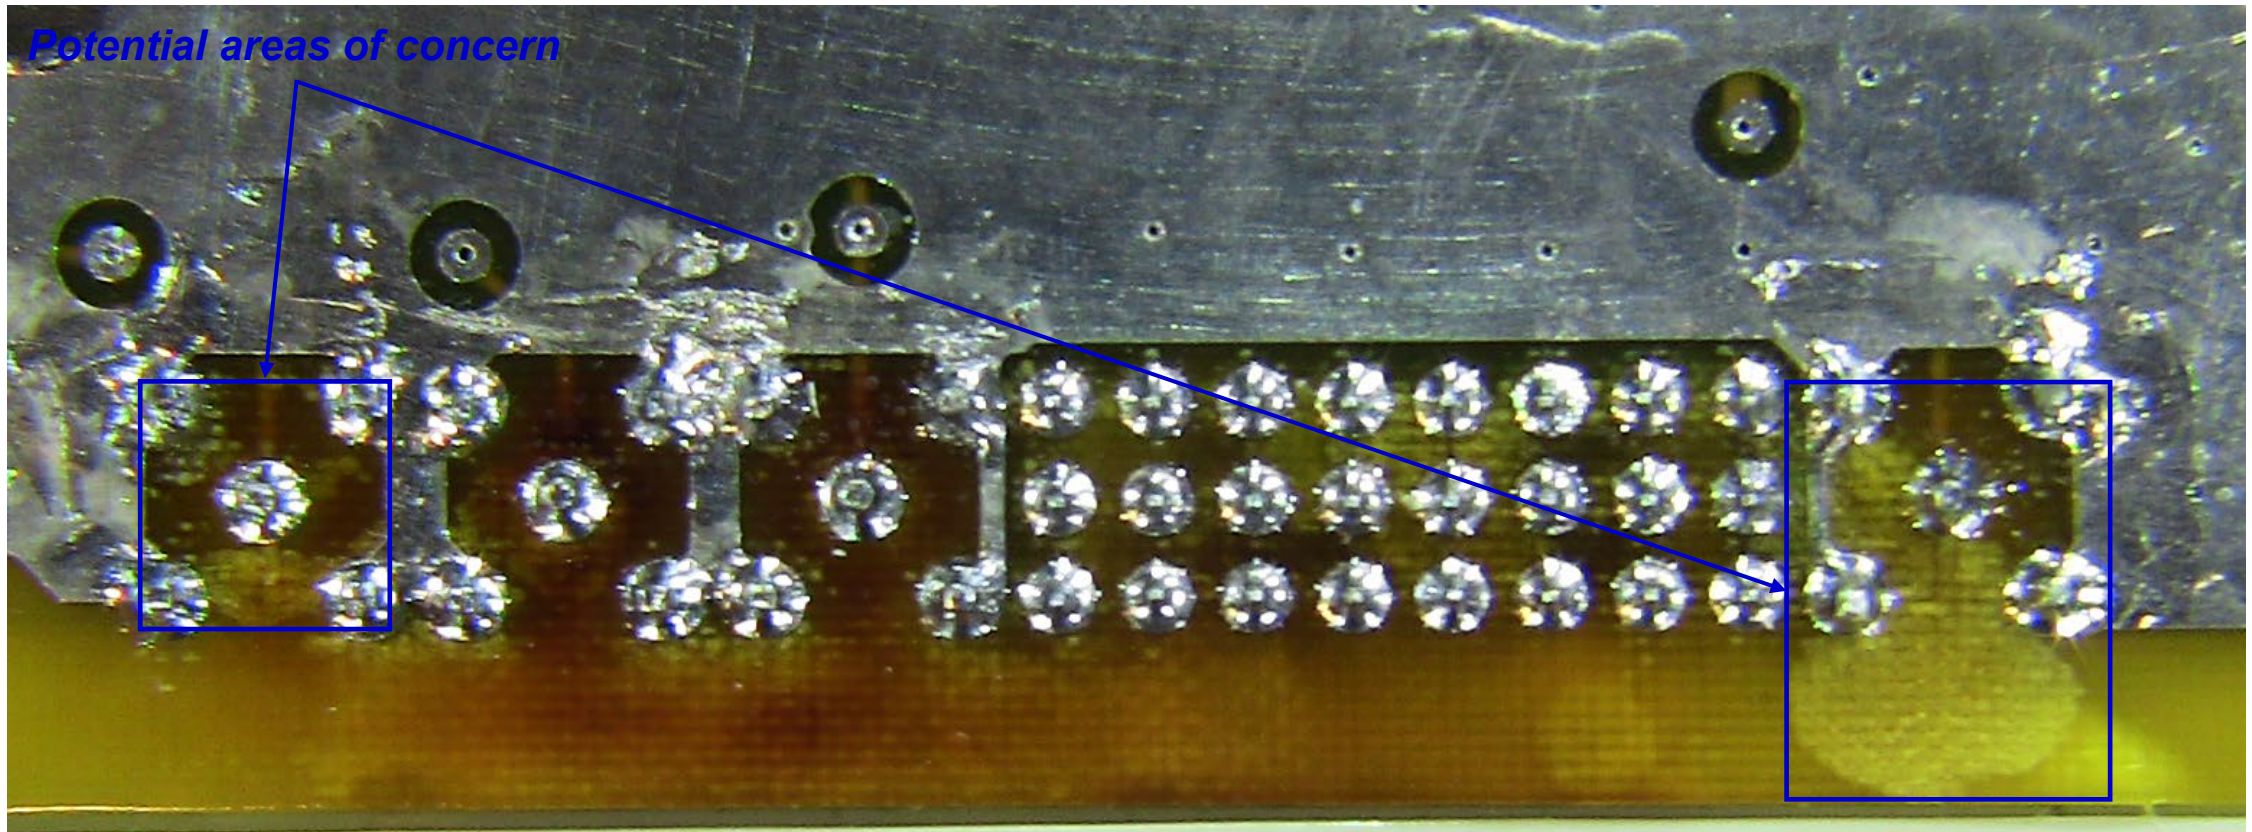
## P2 Connector Backside- Close up, Discoloration / Blistering

PWB substrate- Signs of heat stress & Internal blistered/separated fiberglass reinforcement from rework

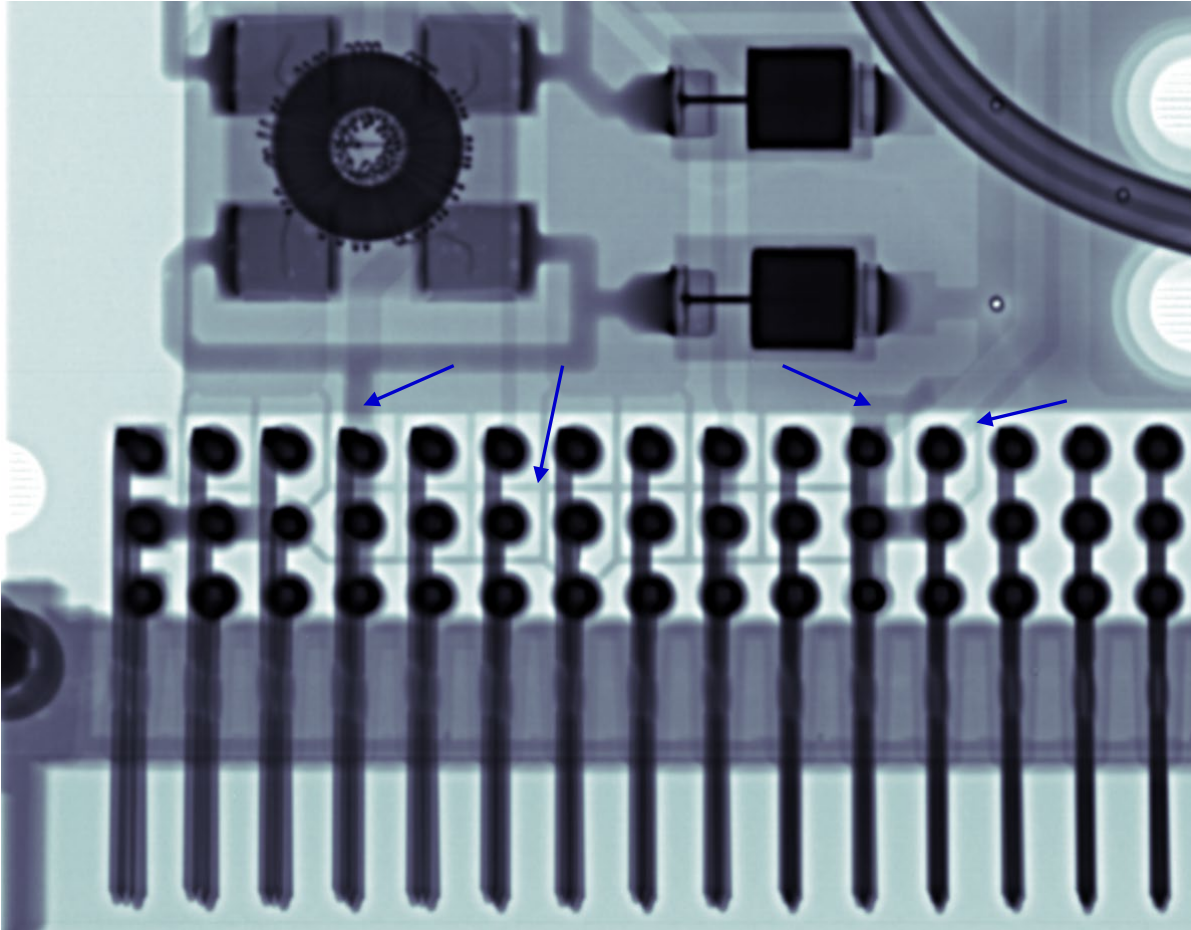
**P1 X-ray-** Active layer trace connections to pins

Connectors P1 & P2- Active traces P2 connector is pins *ONLY*

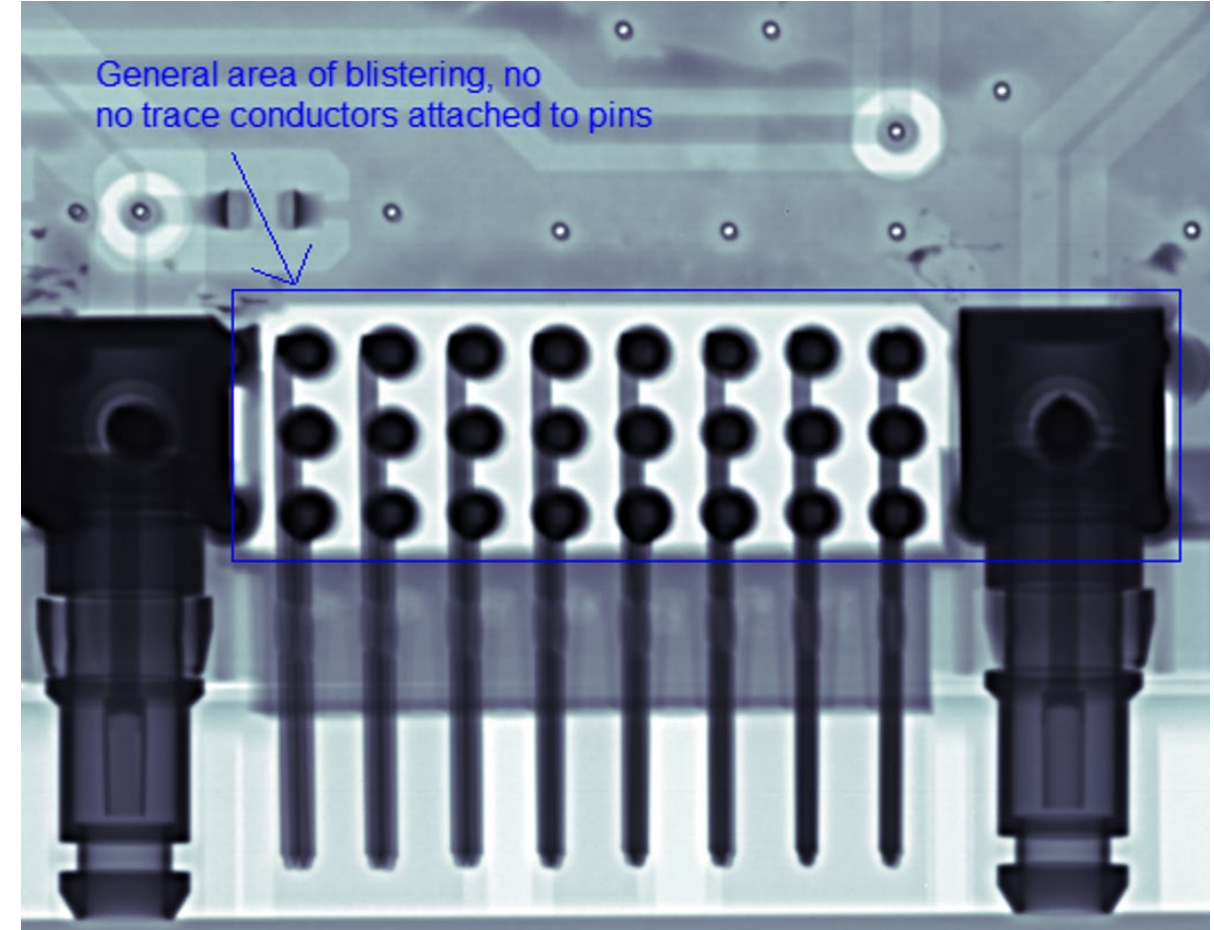
**P2 X-Ray-** No active traces to pins, RF connectors only

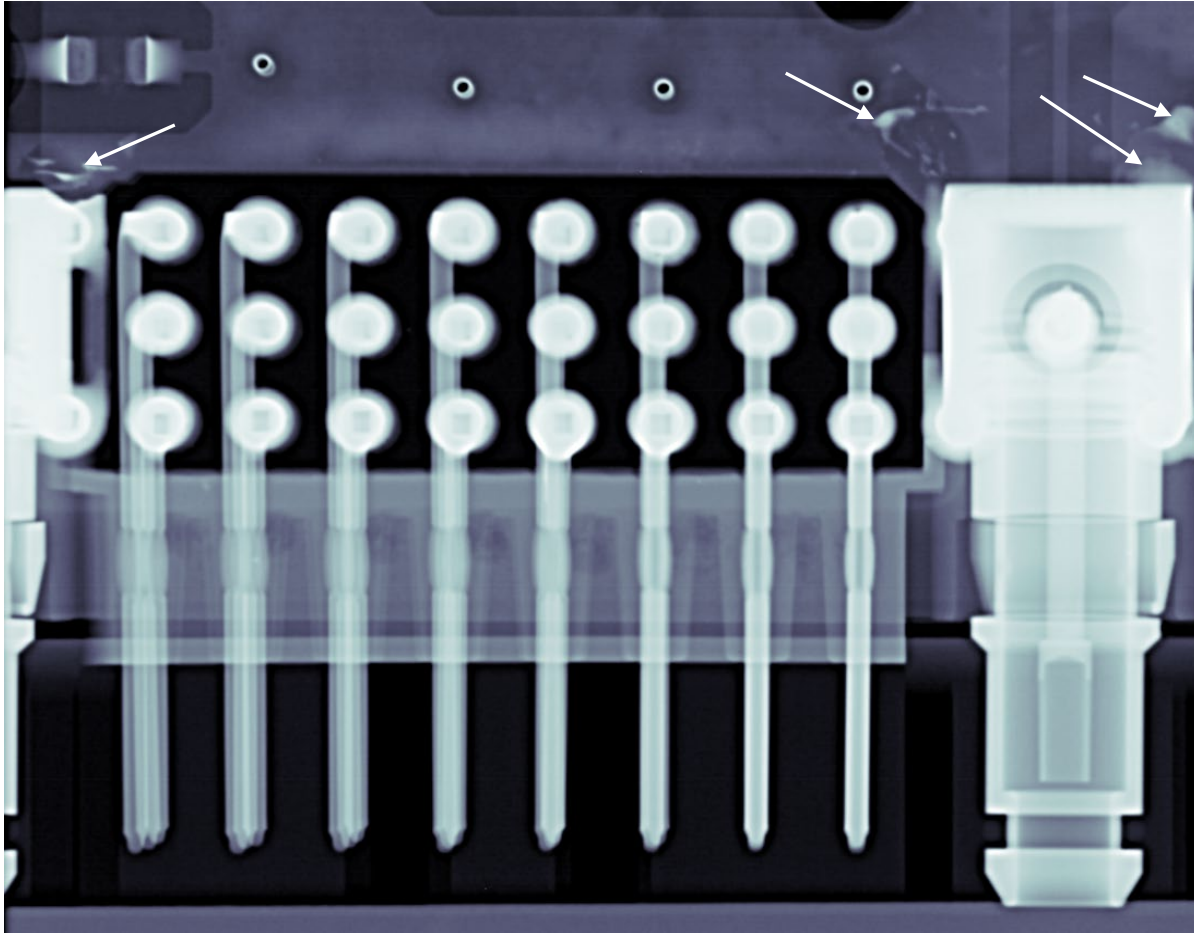
**P2 X-ray-** Area of concern, *Negative*. Highlights solder rework

*P2 Pins & RF Connector- Surface solder reflow highlighted, NO evidence plane or trace damage*

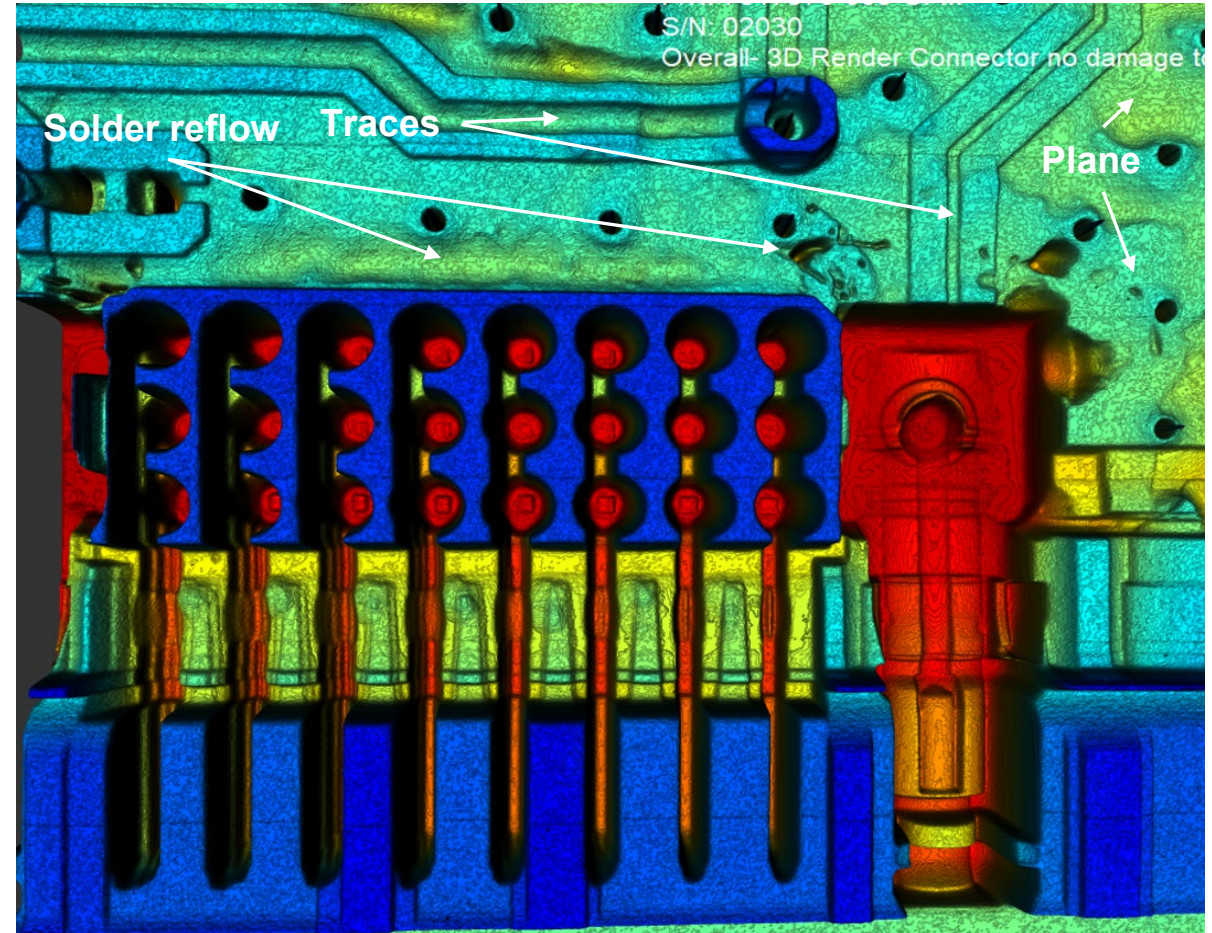
**P2 X-Ray-** 3D Render highlights traces & planes

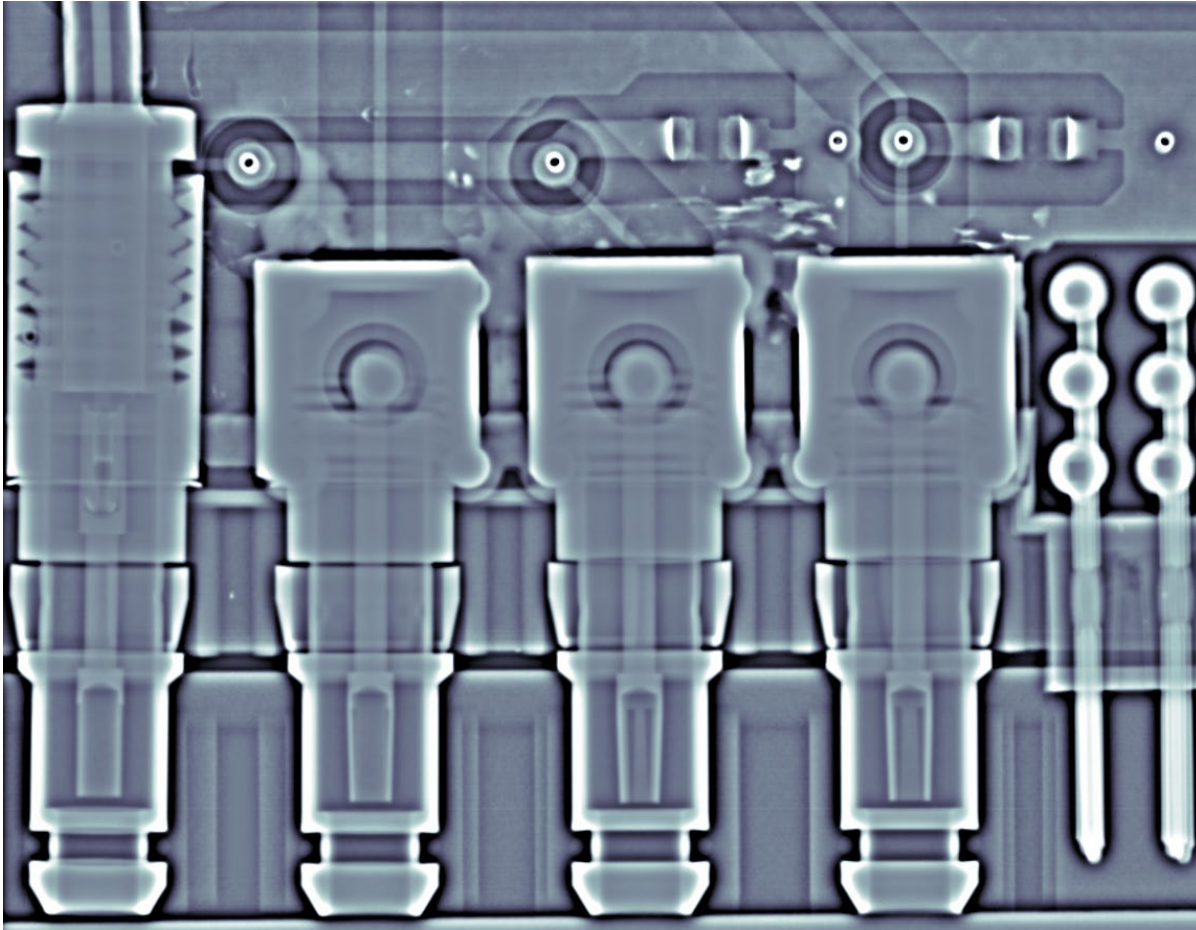
**P2 X-ray-** RF side edge enhancement, connectors In-tact

*P2 RF Connector Side- Edge Enhancement & 3D render show NO evidence plane or trace damage*

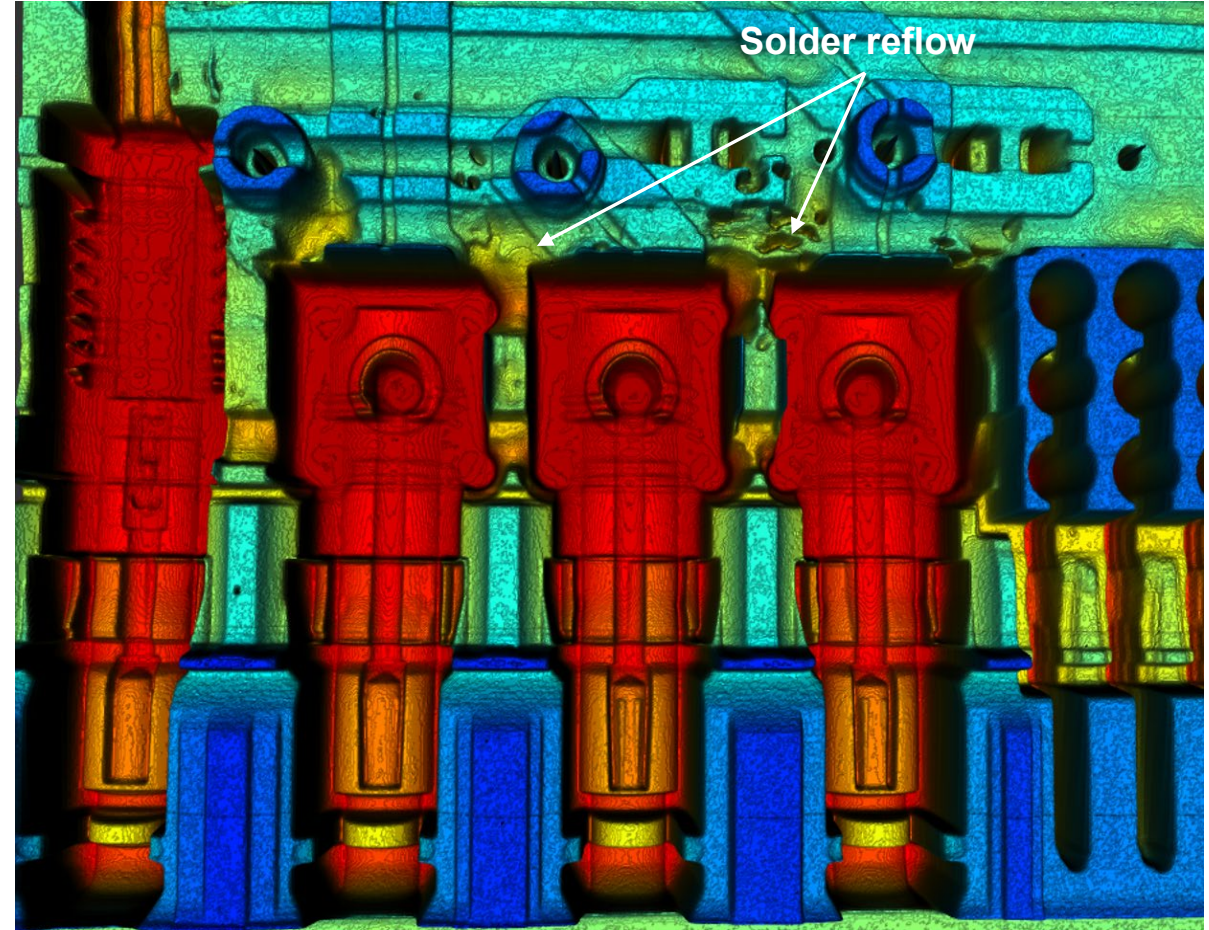
**P2 X-Ray-** RF side 3D render, no evidence of damage
