Legacy Program Engineering Stock Validation and Counterfeit Inspection

Aaron Dermarderosian
Senior Principal General Engineer
Engineering Services, Failure Analysis
04/26/2023 17:05-17:30

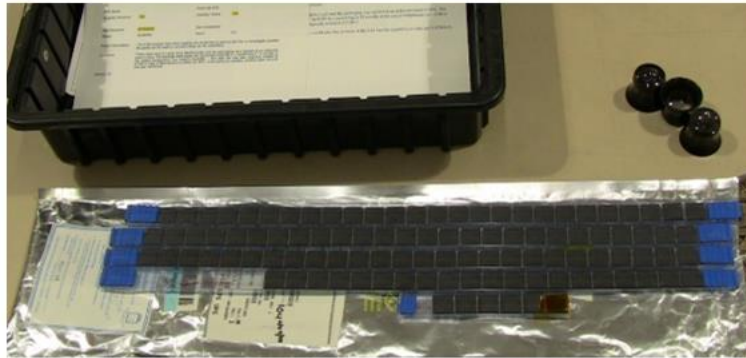
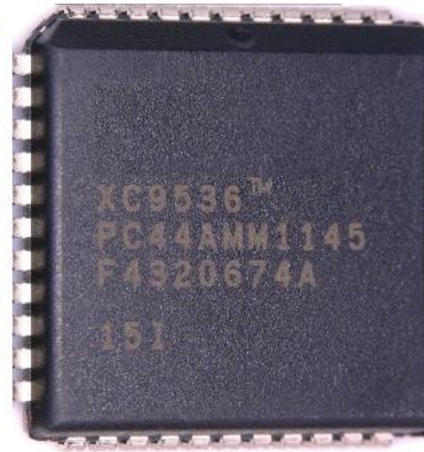
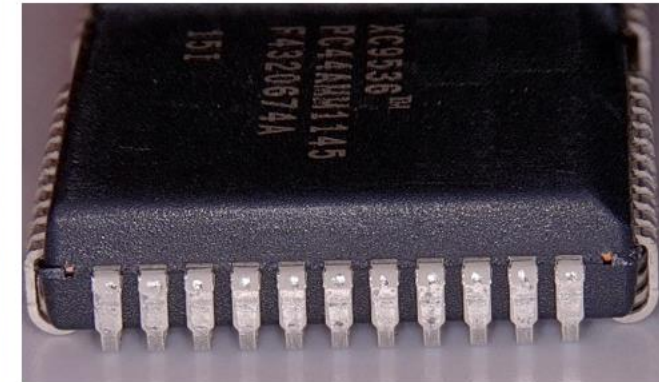
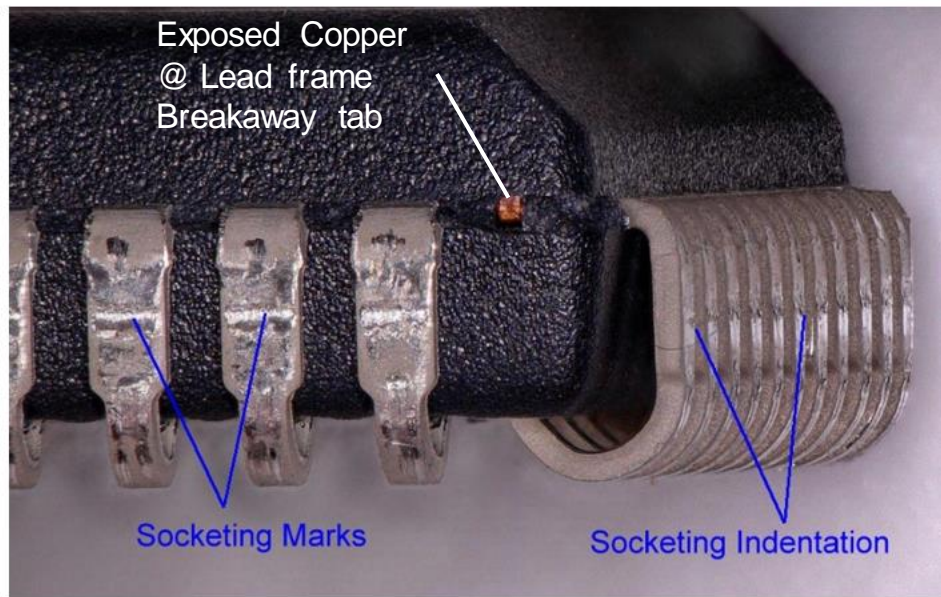
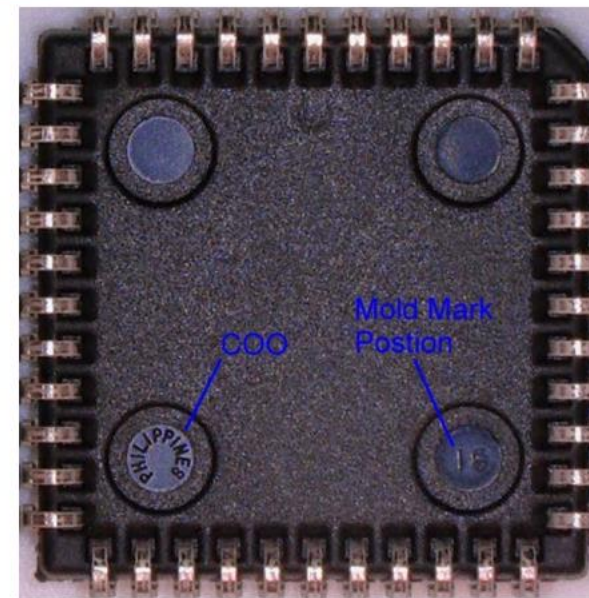
Qty. 104 Components visually inspected. Consistent construction, COO marks & EOL date codes

3.0 Optical Inspection	Complete	Components appear to be new / un-used stock. J-Leads compressed with contact marks, established these were likely socketed for test & programming (CPLD)

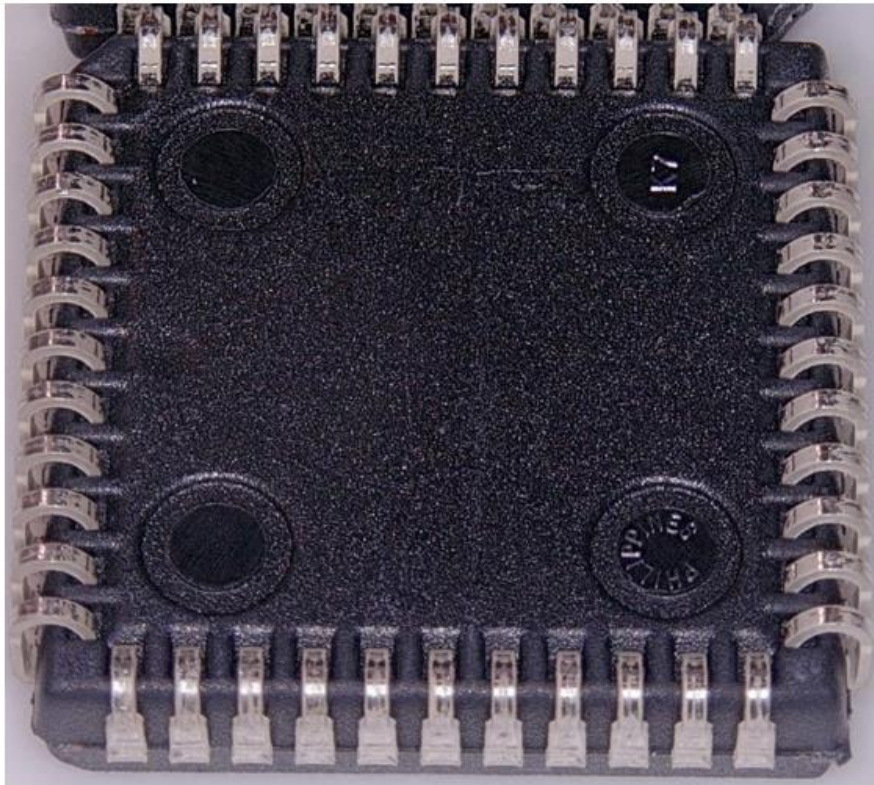
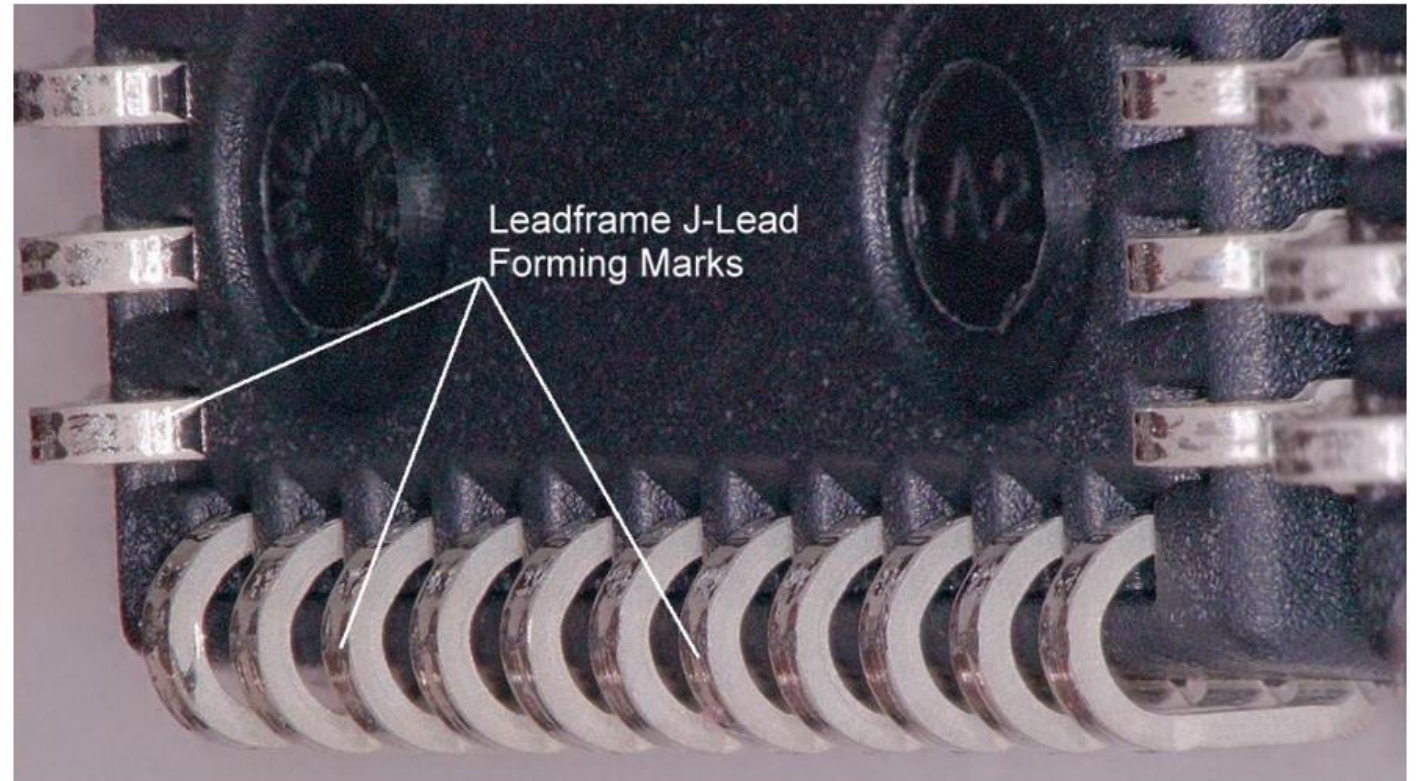
XRF: Lead frame is a Tin/Lead electroplate finish, Nickel Barrier & Copper basis metal

Leads not heavily oxidized. Marks due to J-lead formation & socketing for programming / test

4.0 X-ray Fluorescence	Complete	PLCC lead frames are electroplated with Tin-Lead plating, Nickel barrier & Copper basis metal
5.0 Solderability	Complete	Per J-STD-002E, Method 4.2.1, TEST A. Qty. 3 Components allocated for test. (2) Sides assessed, Qty. 66 Leads total. PASSED. Requirement > 95% Coverage. Measured > 99%

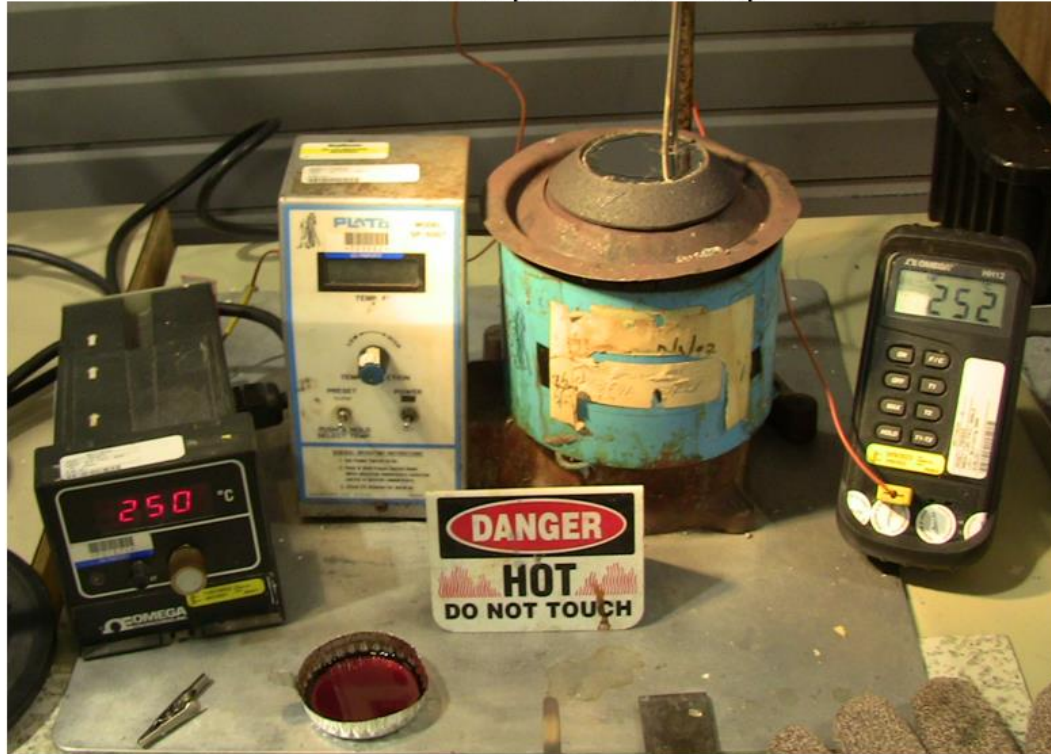
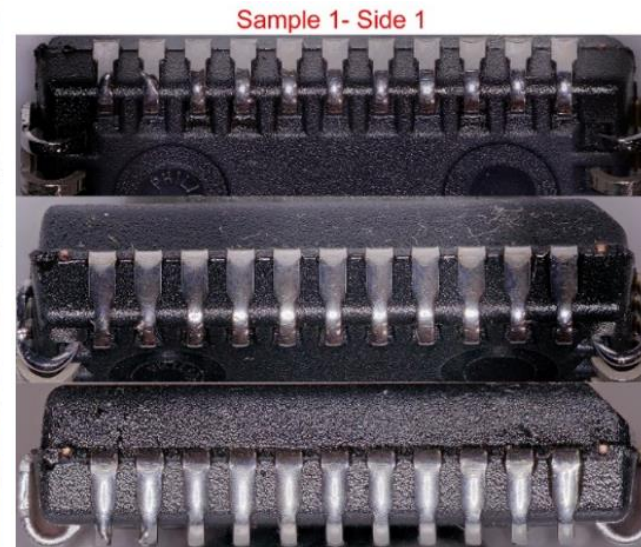
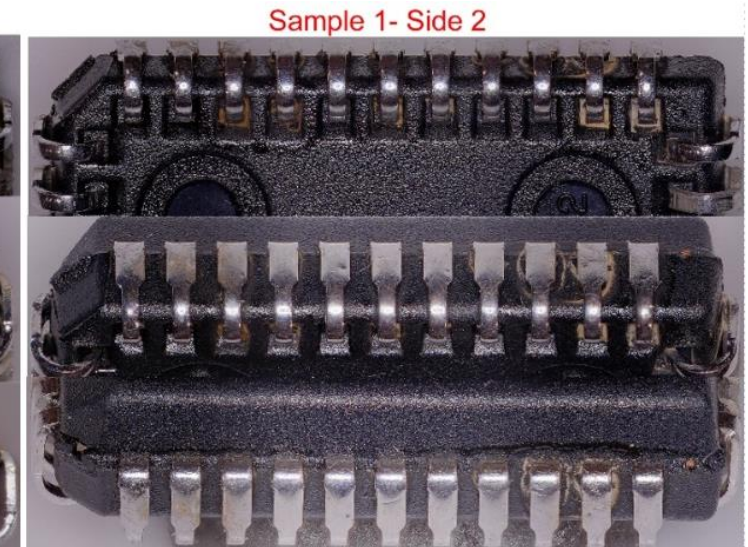
Solder Sample Test Setup

Setup: Samples tested on 2 of 4 sides; 22 leads per device, 66 total. Pre-flux with 45° angle dip

Pass/Fail Criteria: All leads MUST have > 95% coverage, without blistering, peeling, or signs of de-wetting due to contamination or corrosion defects

Qty. 3 Samples randomly selected for destructive test. TEST IAW J-STD-002E ; Method 4.2.1 Test A.

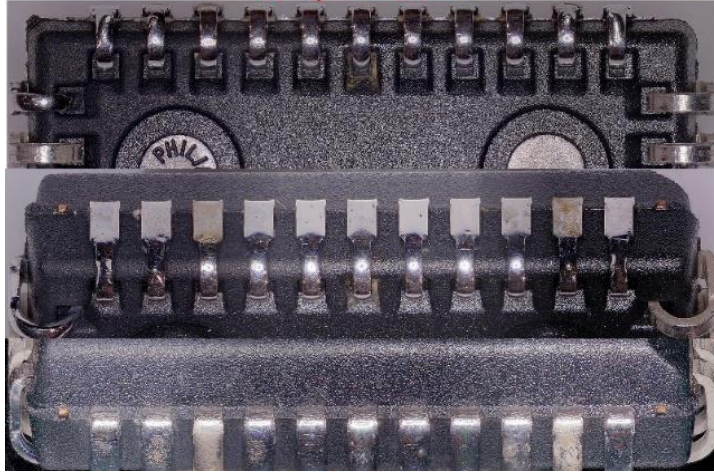
Sample 2- Side 1

All leads (66) on Three Samples showed >99% coverage. Lead re-plating is **NOT** Required.

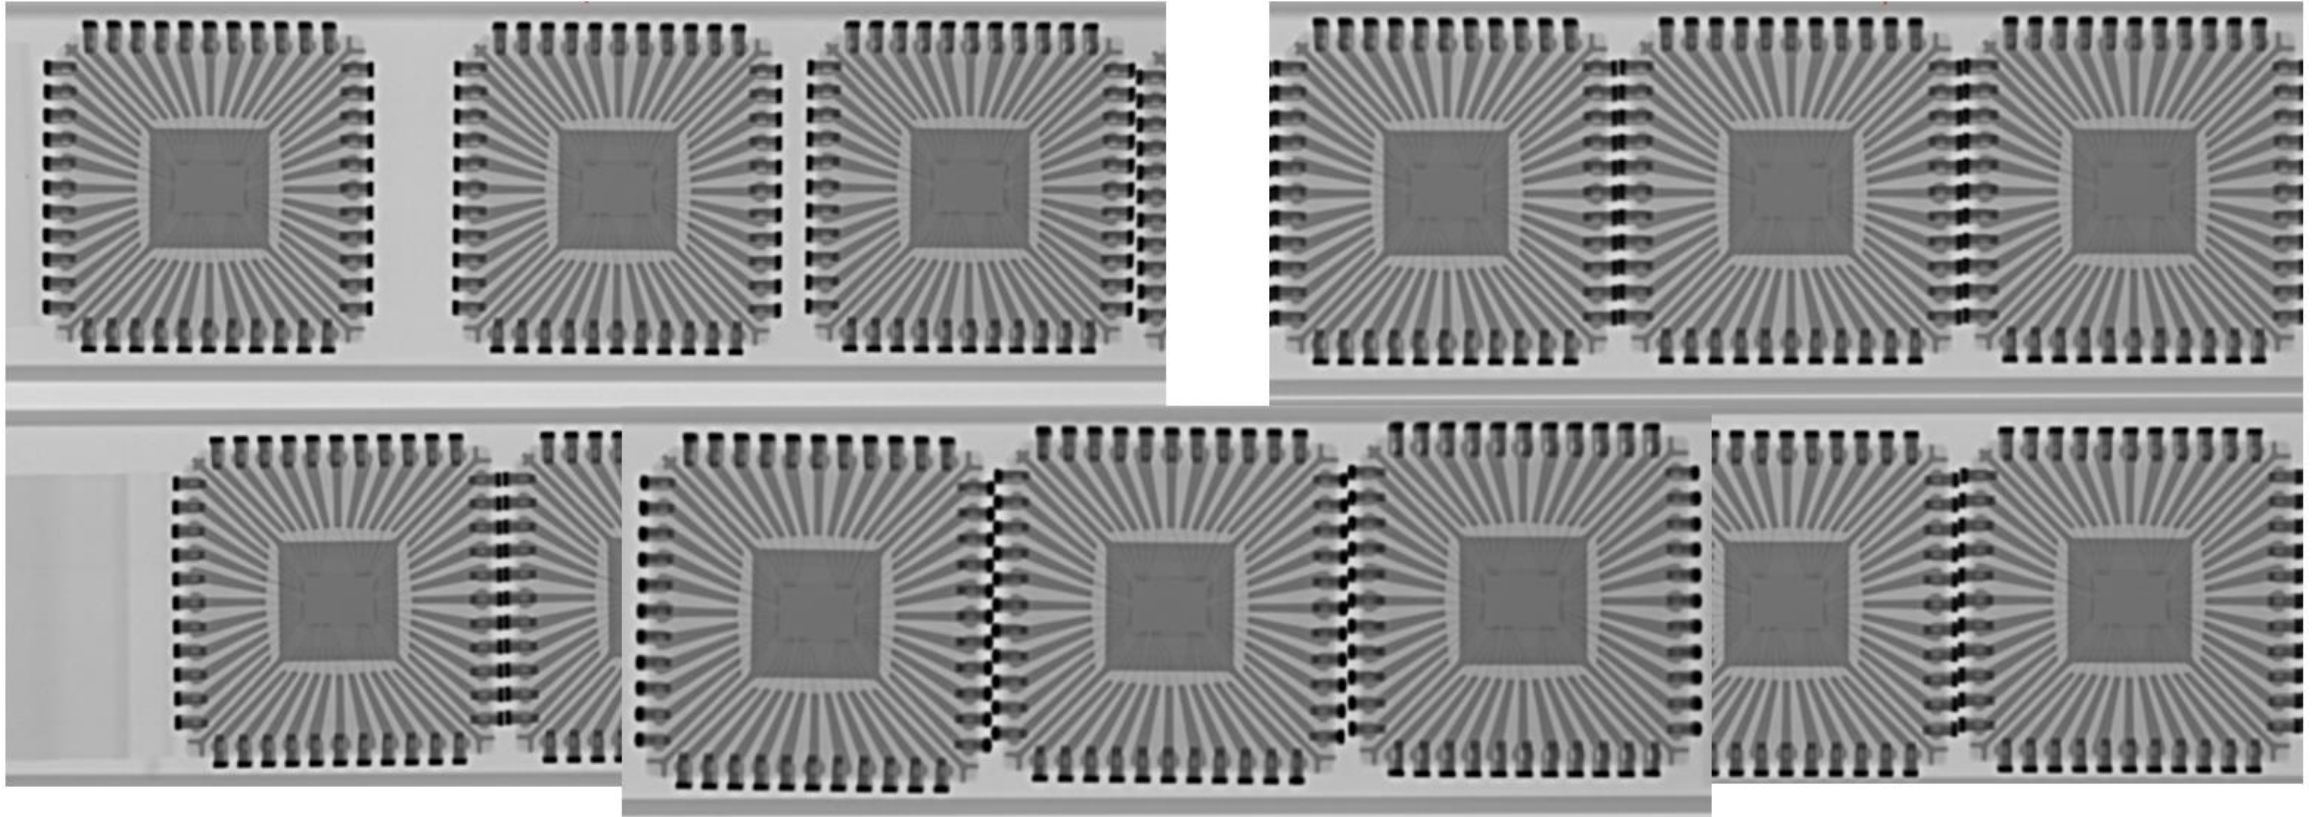
3 lot sites were selected for X-ray. Showed consistent lead frame, die & wire bond construction

6.0 Cursory X-ray	Complete	All components have consistent construction with no voiding, wire bond, lead frame or part to part variability issues
7.0 Component Thickness	Complete	Average Component thickness is: 0.1530 in. (3.8862 mm), required for bake out time calculation

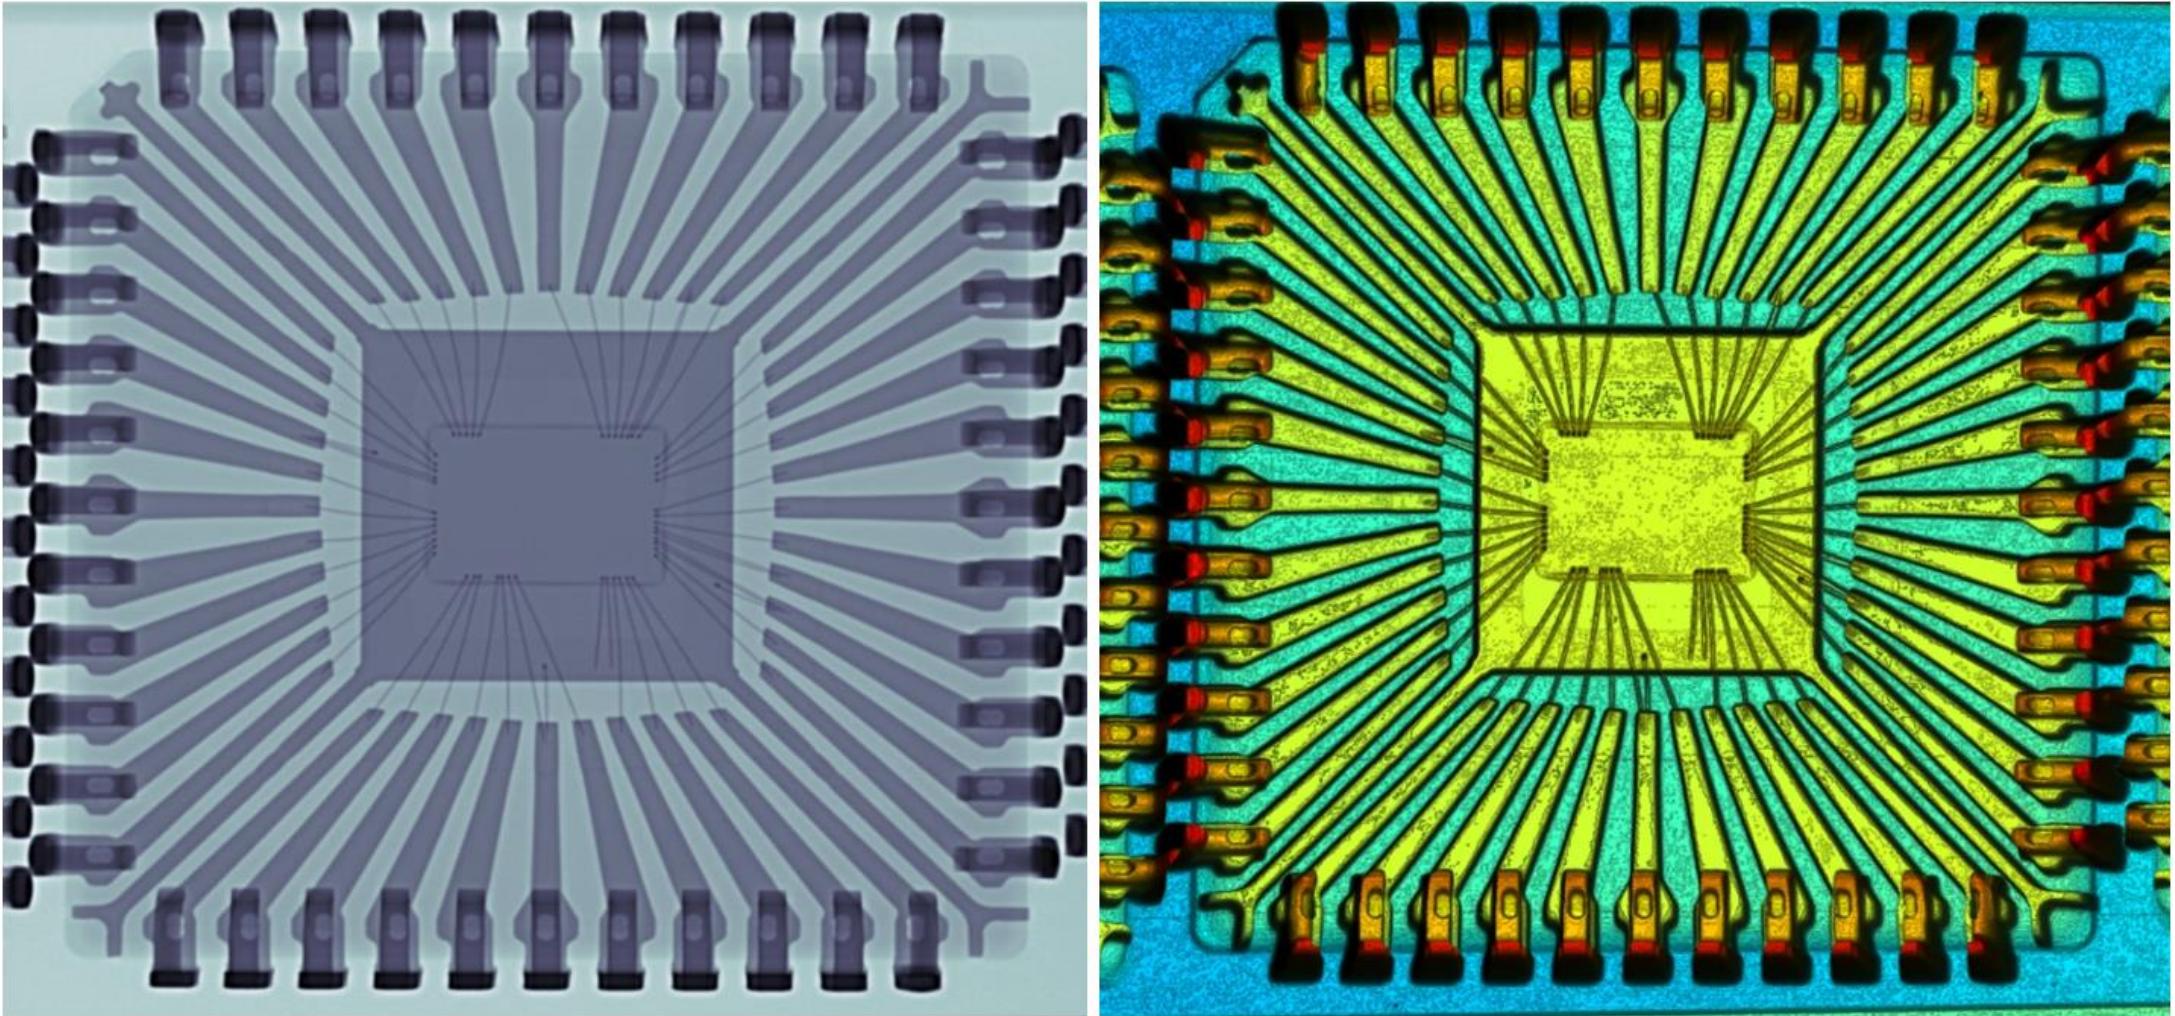
3 lot sites were selected for X-ray. Showed consistent lead frame, die & wire bond construction

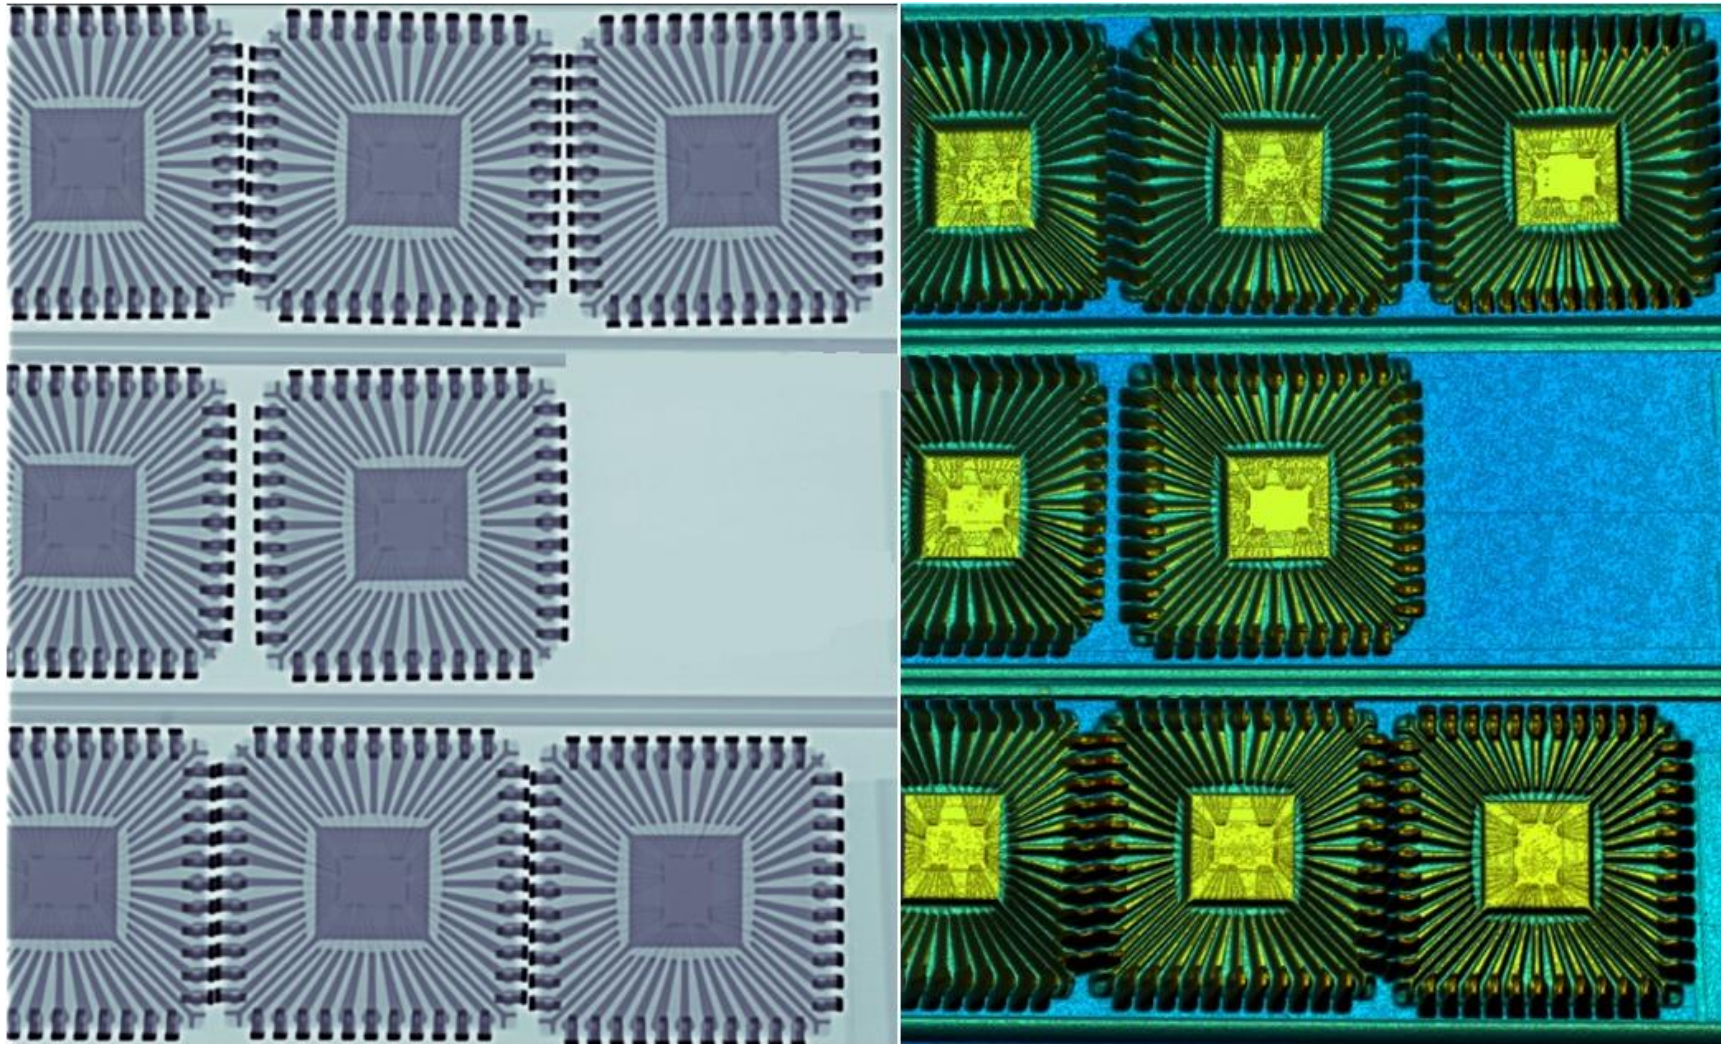
3 lot sites were selected for X-ray. NO Issues encountered during internal inspection

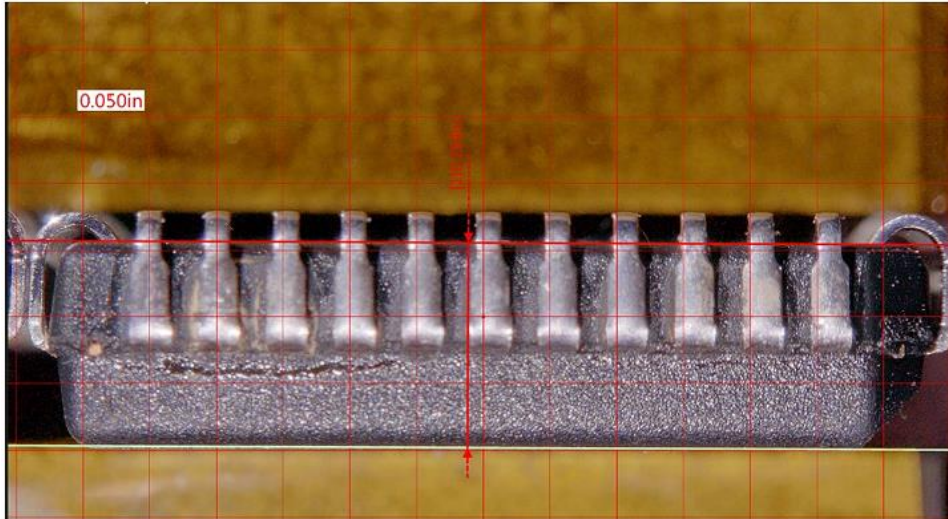
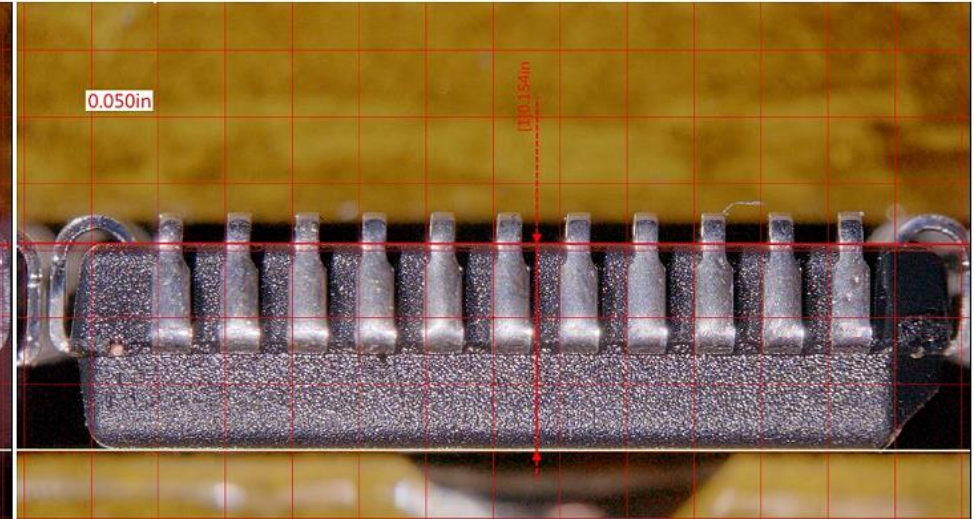
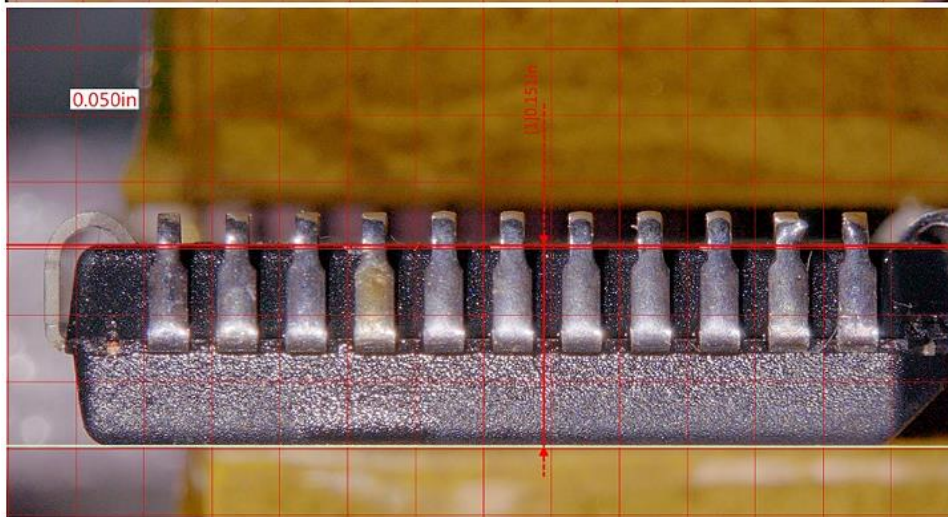
S1. 0.154 in.

S2. 0.154 in.

S3. 0.151 in.

$0.459 \text{ in.} / 3 = 0.1530 \text{ in.}$

Physical dimensional measurements are inline with supplier datasheet

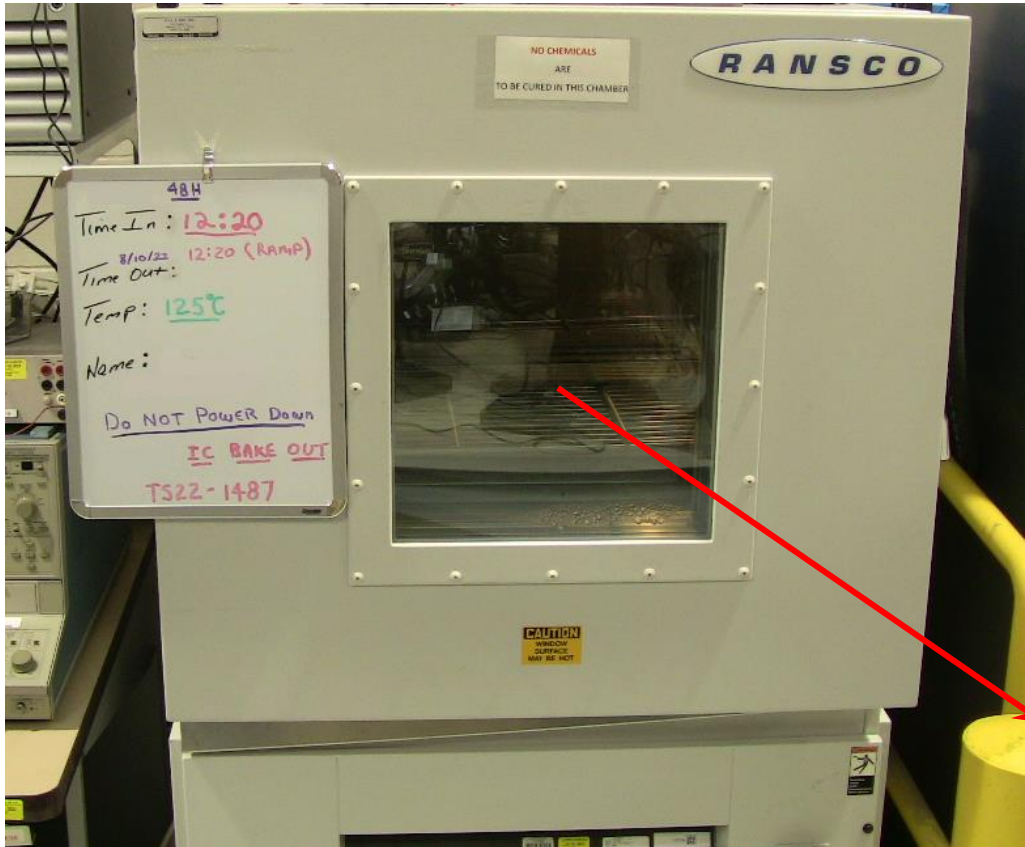
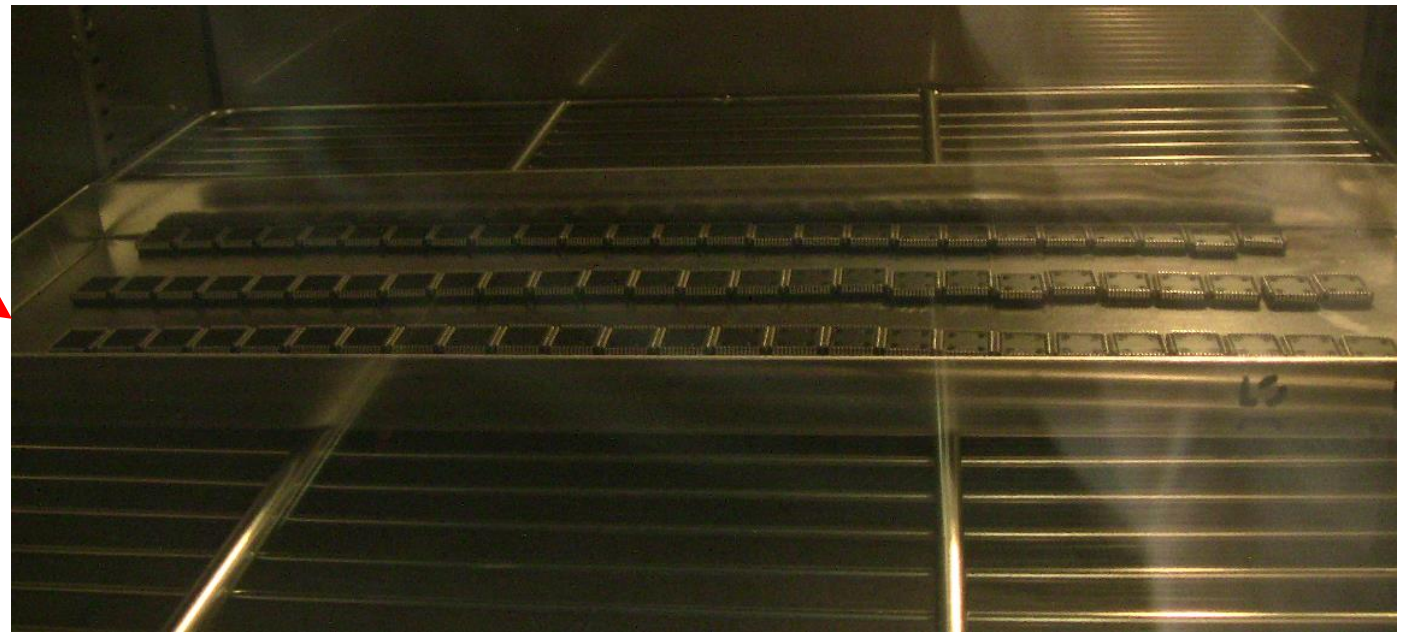
Completed Bake out after 48 hours @ 125°C. Product Stabilized to 30°C for 2 hours

8.0 Bake out Calculation	Complete	Per J-STD-033D, Table 4.1. PEM requires 48 hours (2 days) @ 125 Deg. C.
9.0 Monitored Bake out	Complete	Completed in monitored oven; 8/8 to 8/10. 1H Ramp Up – 48H Dwell – 1H Ramp Dn

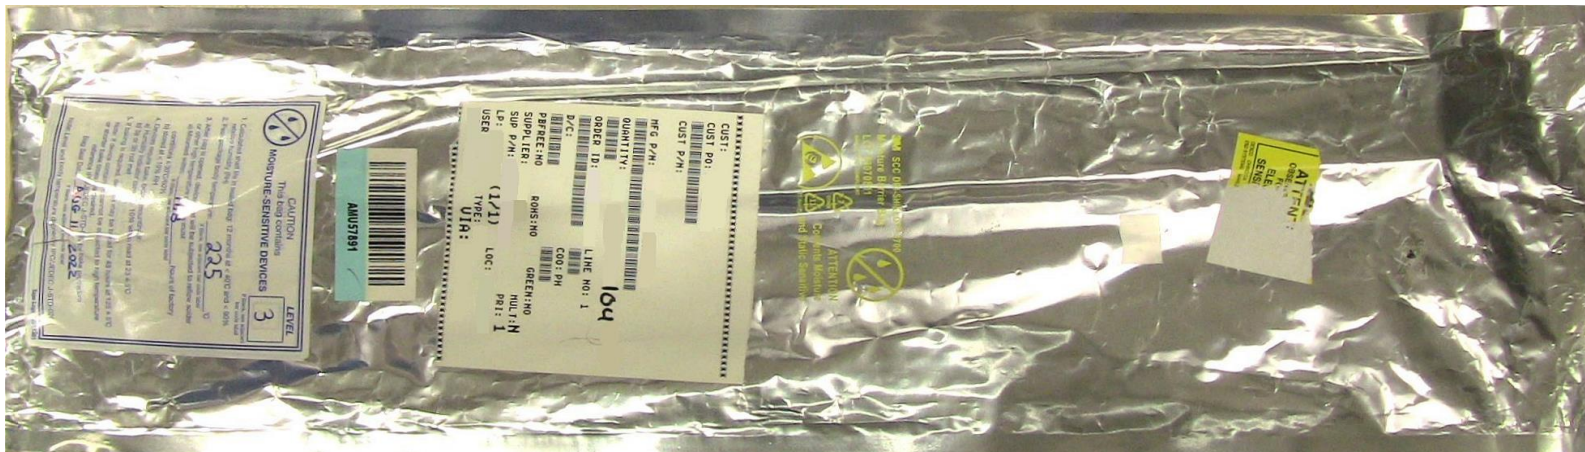
Sealed in Moisture Barrier bag (MBB), with Desiccant & Humidity Indicator Card

Bake out date documented with label applied; New Desiccant & HIC sealed with components

10.0 Reseal Process	Complete	Resealed with Desiccant, Humidity Card and MSD Label, RTX Stores Logistics assisting.
