Supply Chain Quality Challenges

Cybord Ltd.

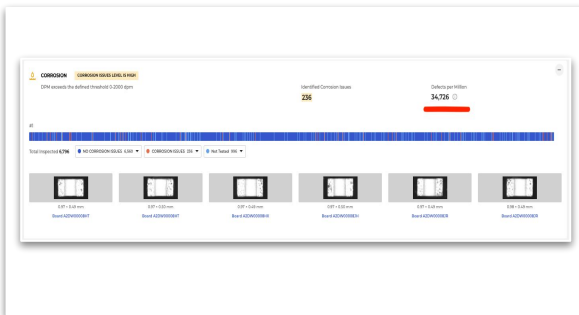
Remove / block contaminated Reels

Recognize

when a specific reel should be taken off the SMT line after analyzing a few components.

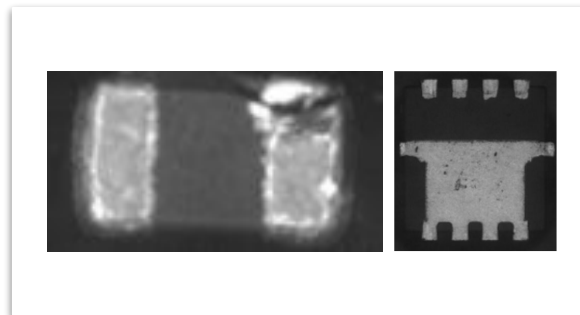
Flag faulty components on board

Identify

board issues in near real-time (1 minute) and raise alerts through the dashboard.

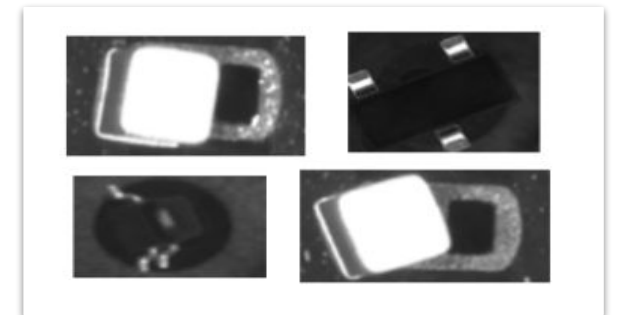
Improve process by feedback to EMS

Detect

bad pickups, overexposed and blurry images, and tombstone, helping operators to quickly address root cause.

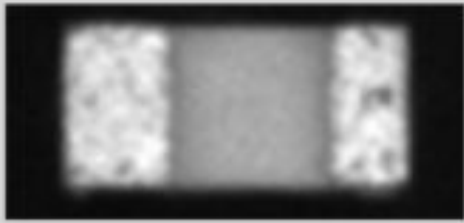
Cybord Alert

A large OEM was alerted by the Cybord platform, indicating solderability risk on specific components. The OEM decided to verify the alert by performing SEM-EDX analysis using authorised lab. The results showed that aluminium oxide contaminant had been found.

0.95 × 0.48 mm

Board A2DY000035K

Conclusion: **OEM decided to disqualify all reels from the same batch.**

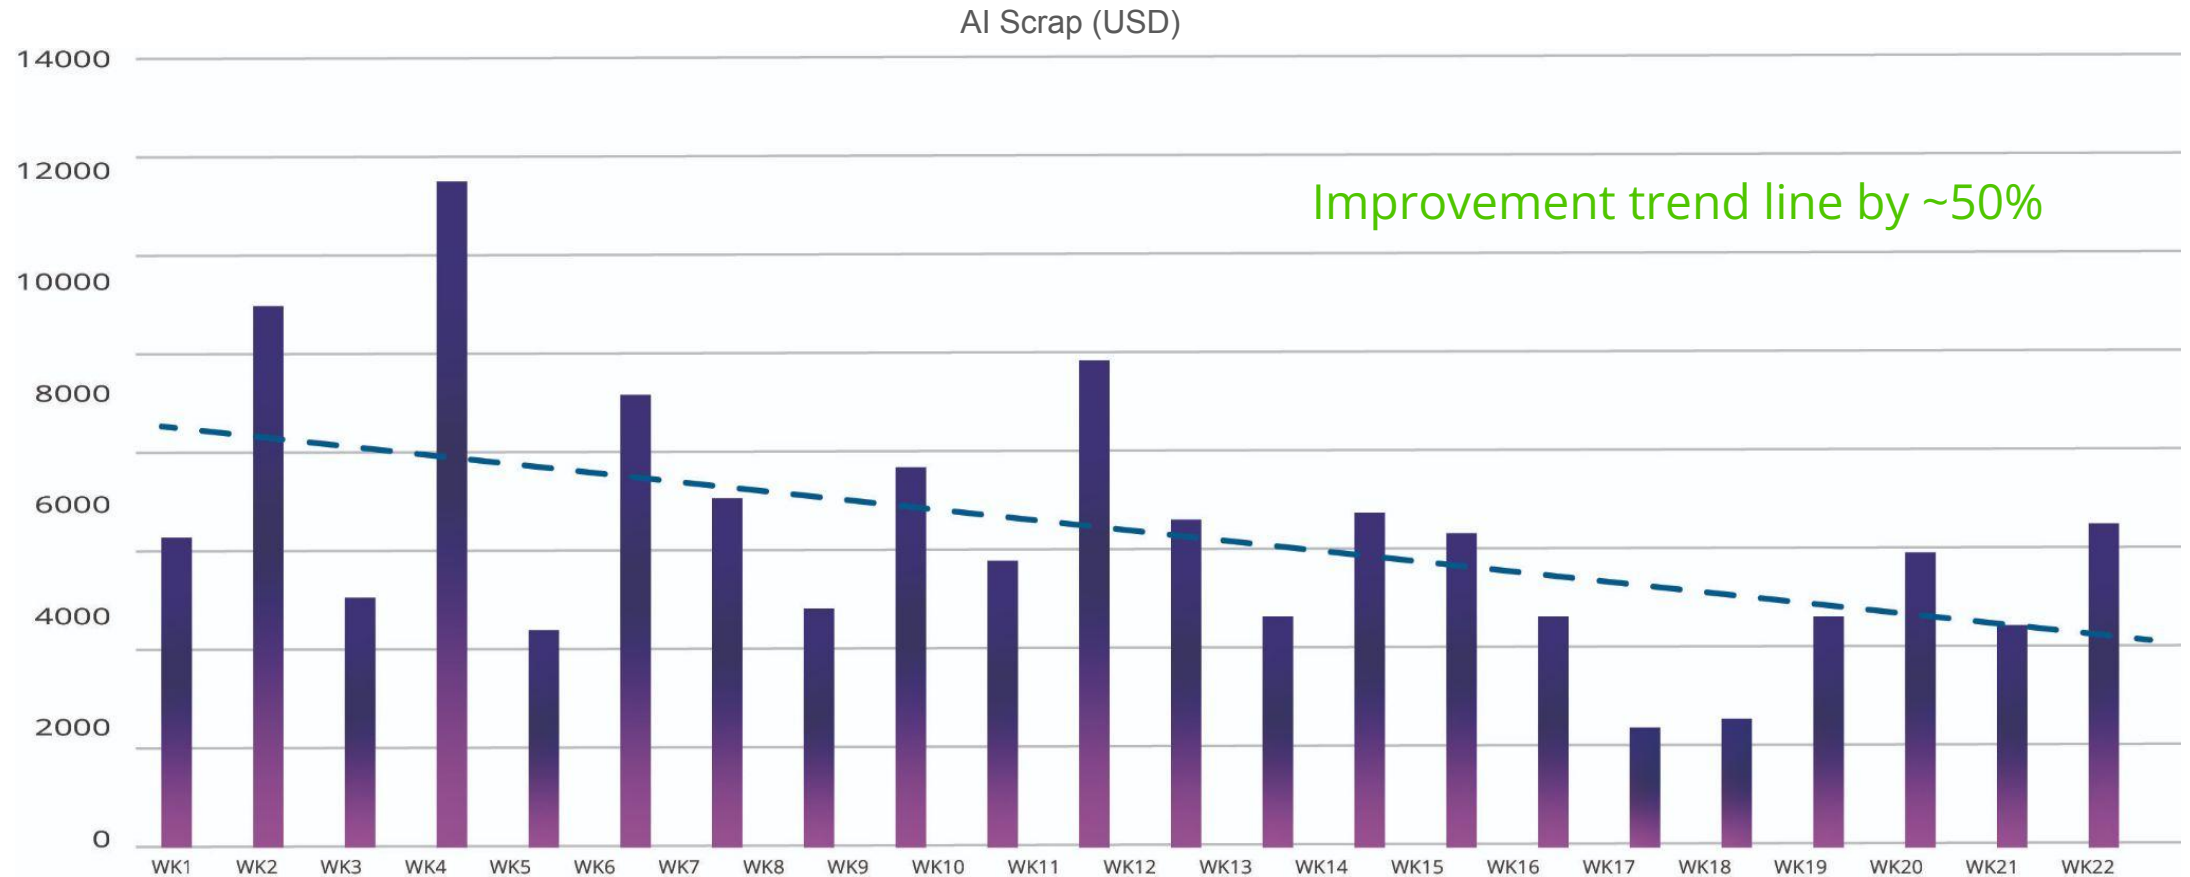
Case Study - Scrap Rate Reduction

A large EMS followed **Cybord set up alerts** for a period of 22 weeks. The following shows the improvement in product scrap rate over this period:

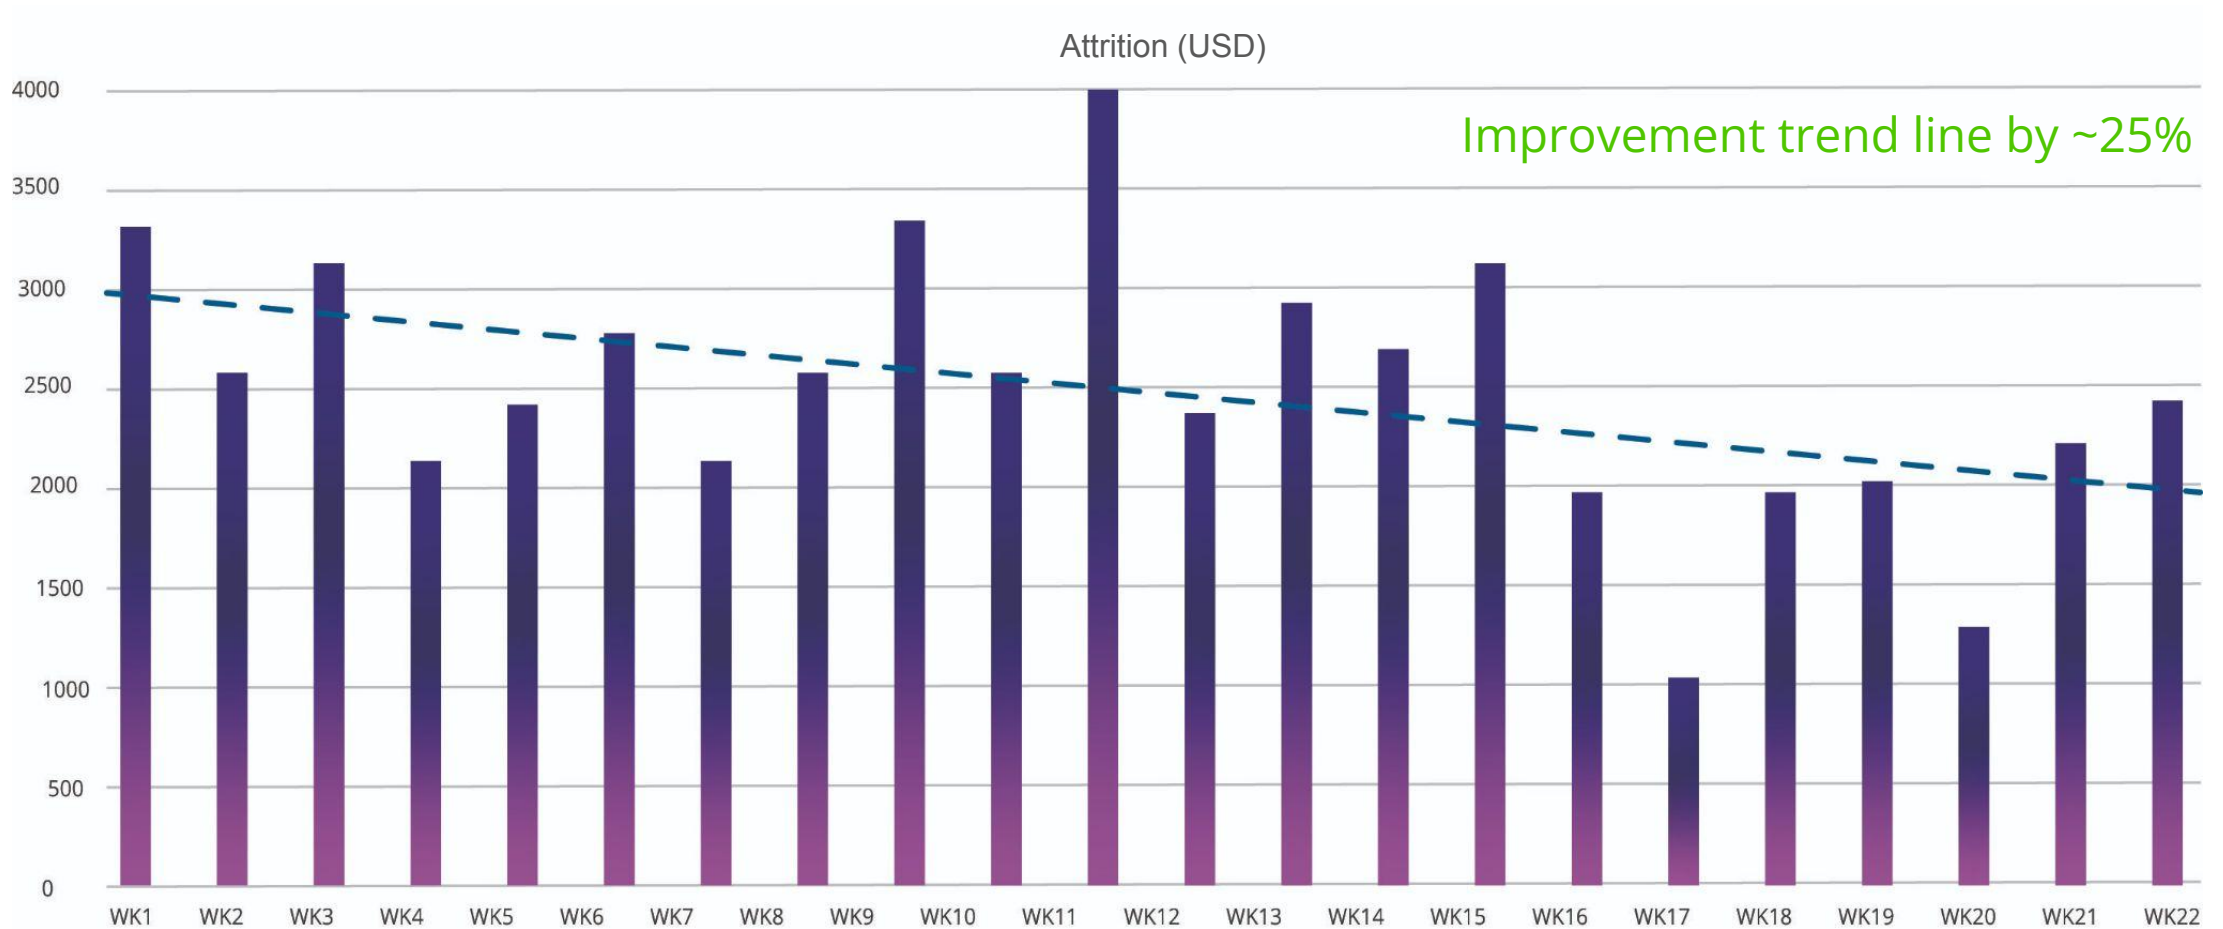
Case Study - Attrition Rate Reduction

A large EMS followed **Cybord vision issue alerts** for a period of 22 weeks. The following shows the improvement in product attrition rate over this period:

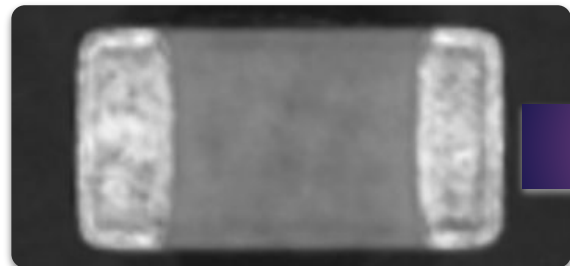
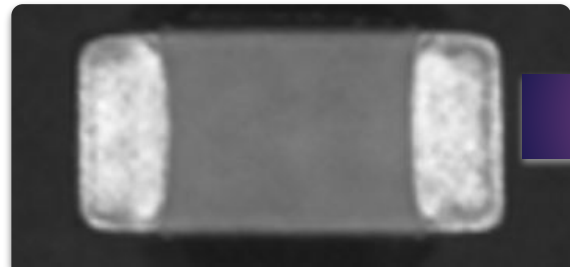
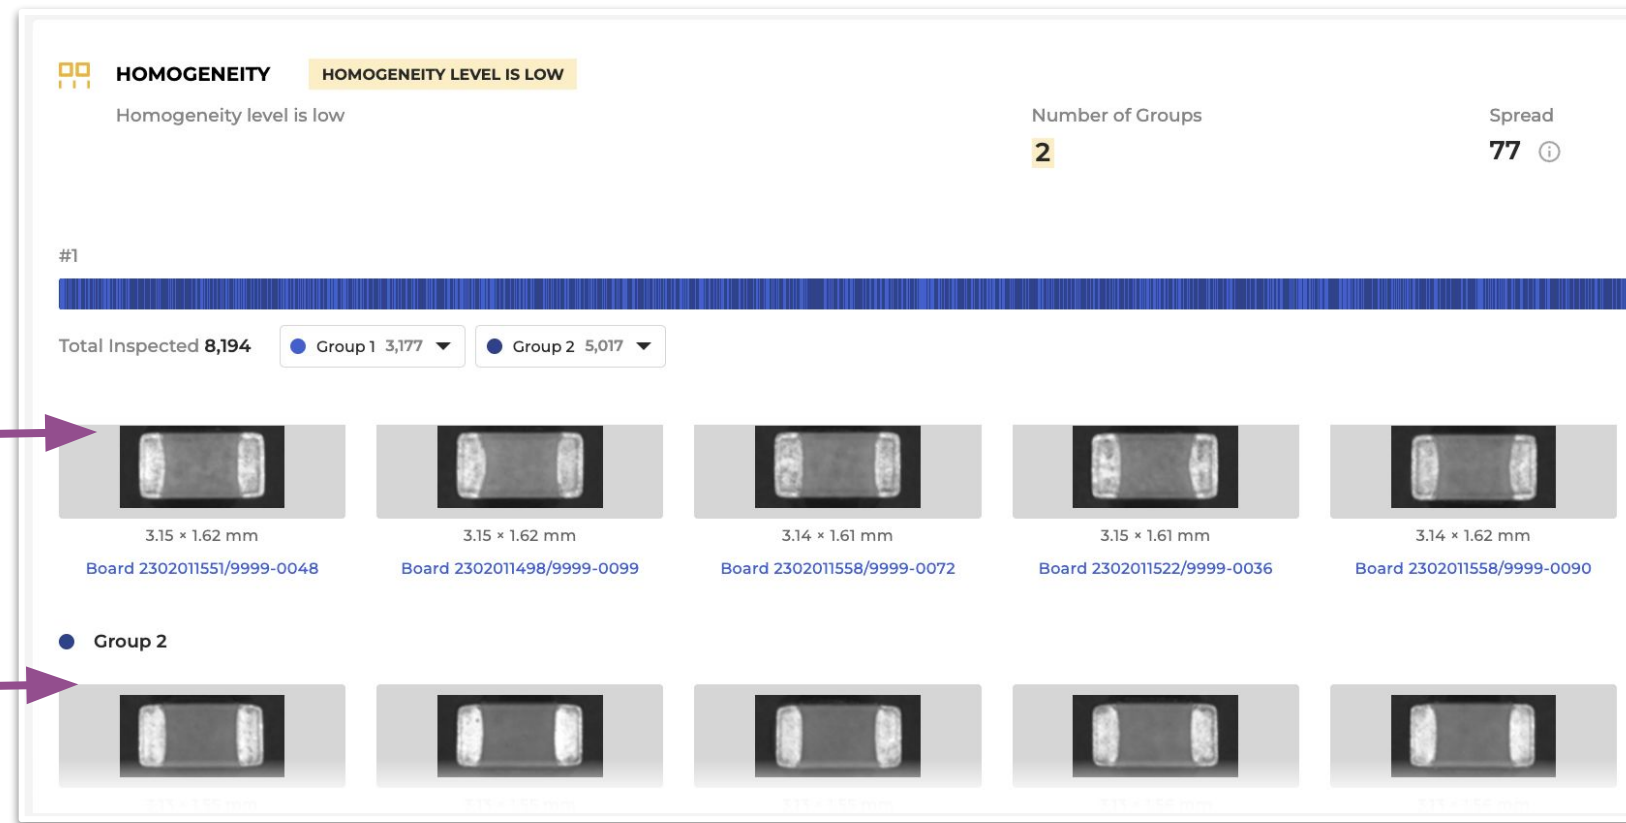
Two Non-Homogenous groups in one reel

The platform raised an alert for two mixed groups in one reel during production.

Group 1

Group 2

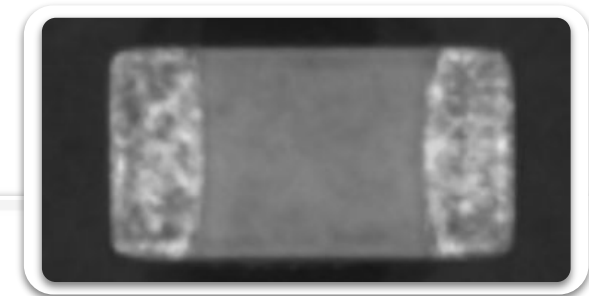
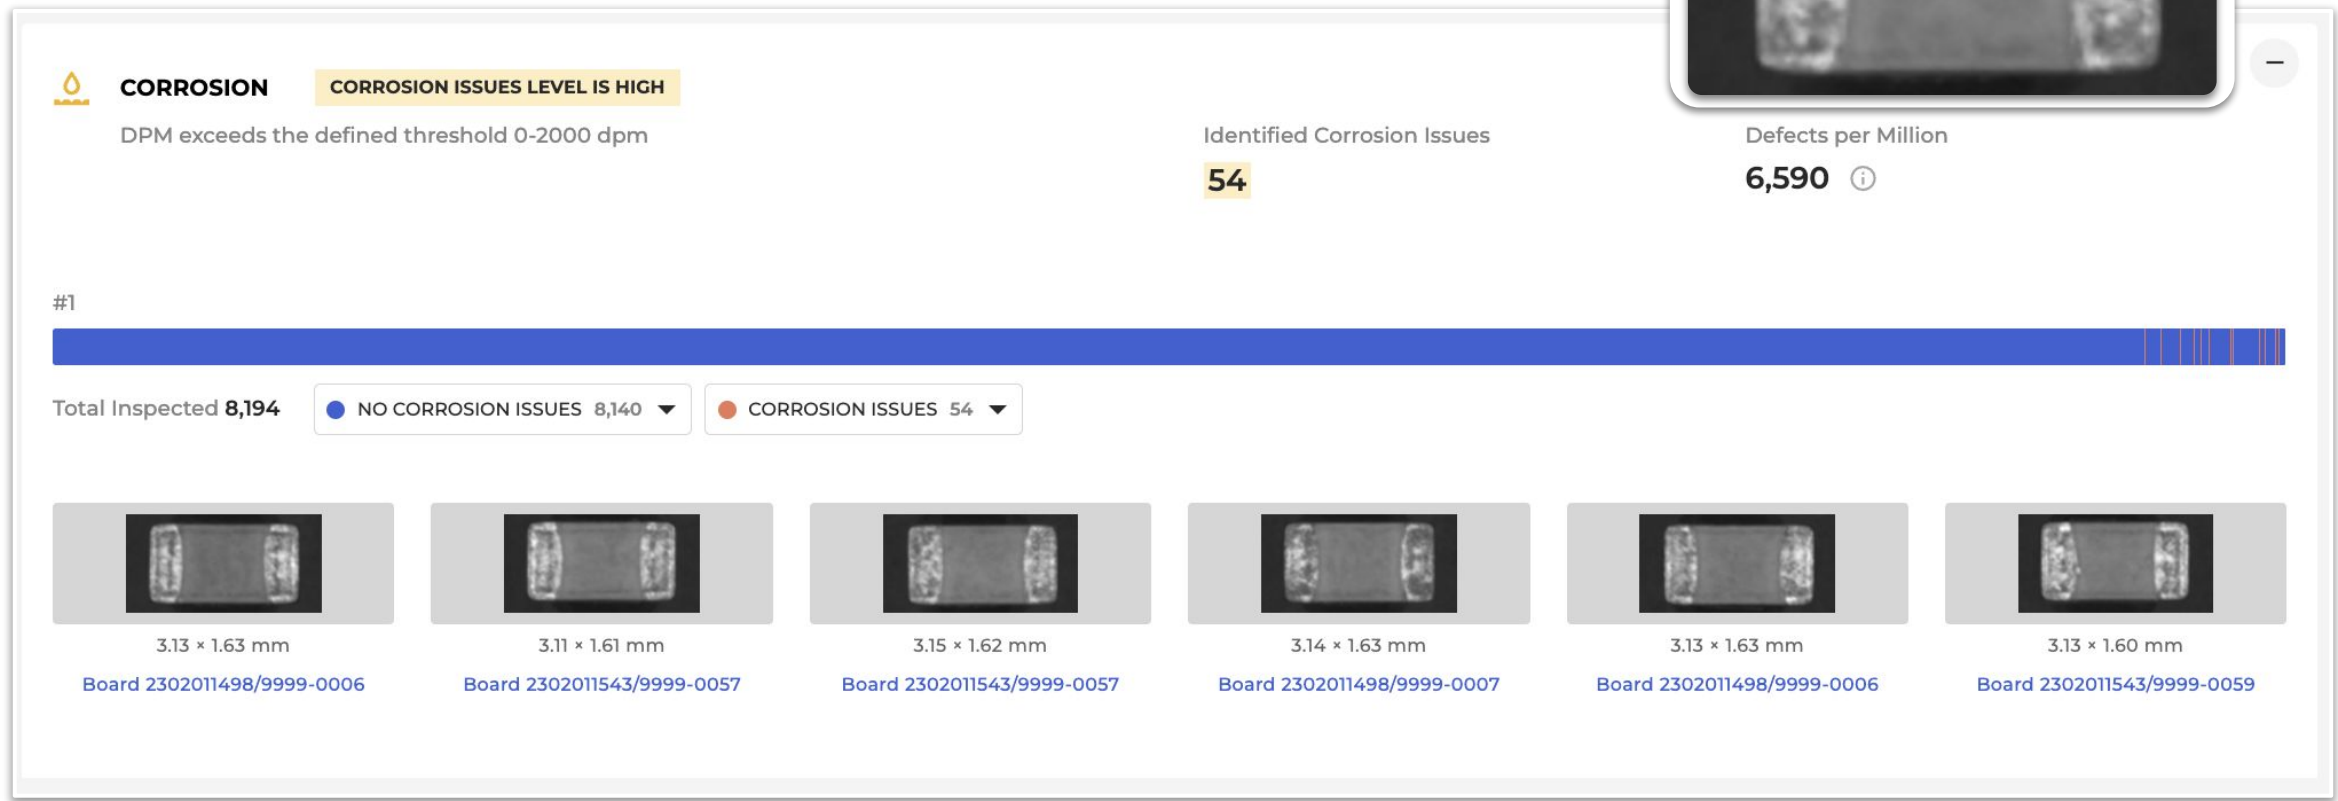
Corrosion contamination on pads

54 components at the end of the reel found with corrosion contaminations which will be implemented in product with low reliability

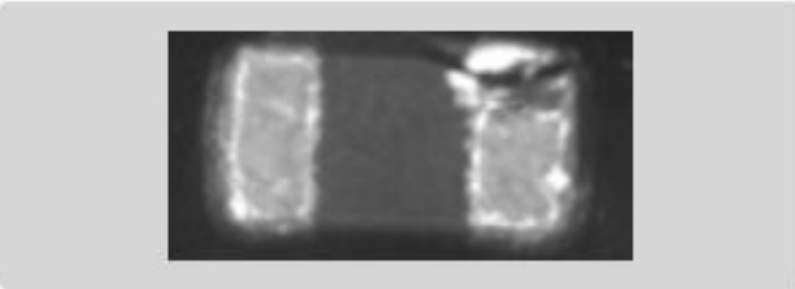
Body defects on boards

This specific component assembled on board.
In case it passed functional tests, it is in a live product, shipped to a customer

BODY DEFECTS
Body defects are within the normal 500 dpm range

NO BODY DEFECTS 27,472 BODY DEFECTS 3 Not Tested 24,987

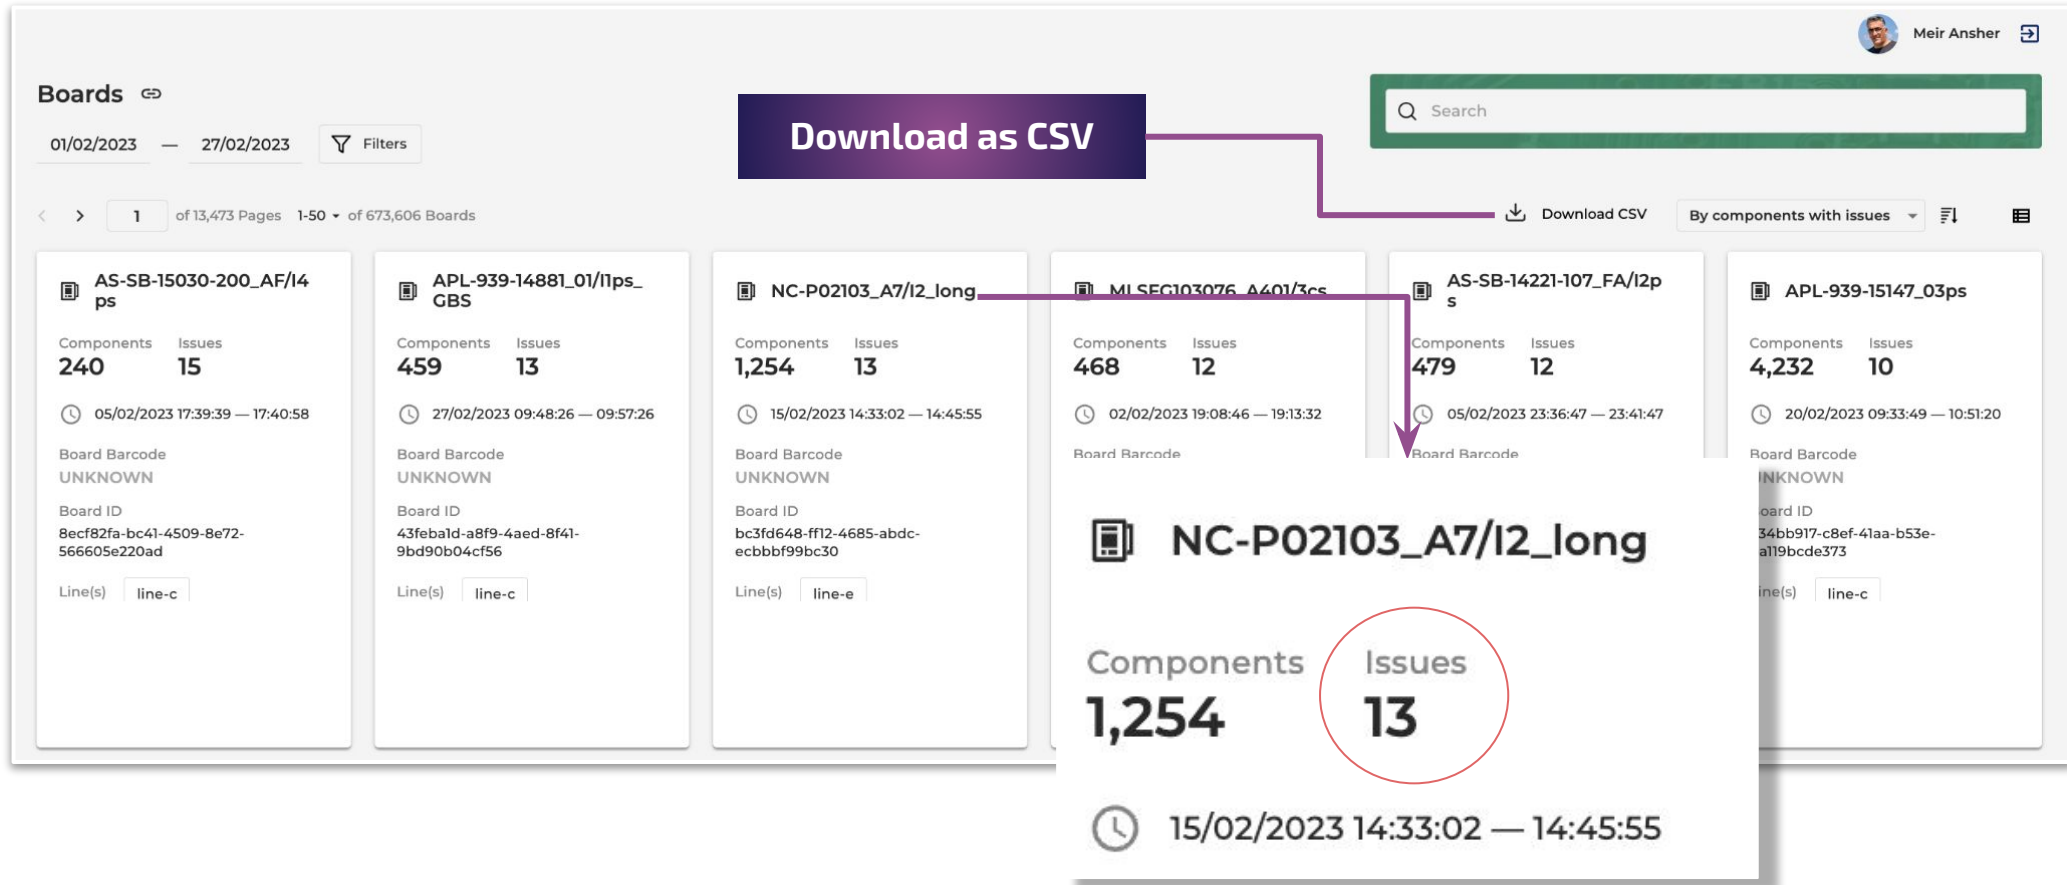
Real-time boards view

During production the platform alert for boards with faulty component issues

Board Name	Components	Issues	Time
AS-SB-15030-200_AF/I4ps	240	15	05/02/2023 17:39:39 — 17:40:58
APL-939-14881_01/I1ps_GBS	459	13	27/02/2023 09:48:26 — 09:57:26
NC-P02103_A7/I2_long	1,254	13	15/02/2023 14:33:02 — 14:45:55
MLSEG103076_A401/3cs	468	12	02/02/2023 19:08:46 — 19:13:32
AS-SB-14221-107_FA/I2ps	479	12	05/02/2023 23:36:47 — 23:41:47
APL-939-15147_03ps	4,232	10	20/02/2023 09:33:49 — 10:51:20

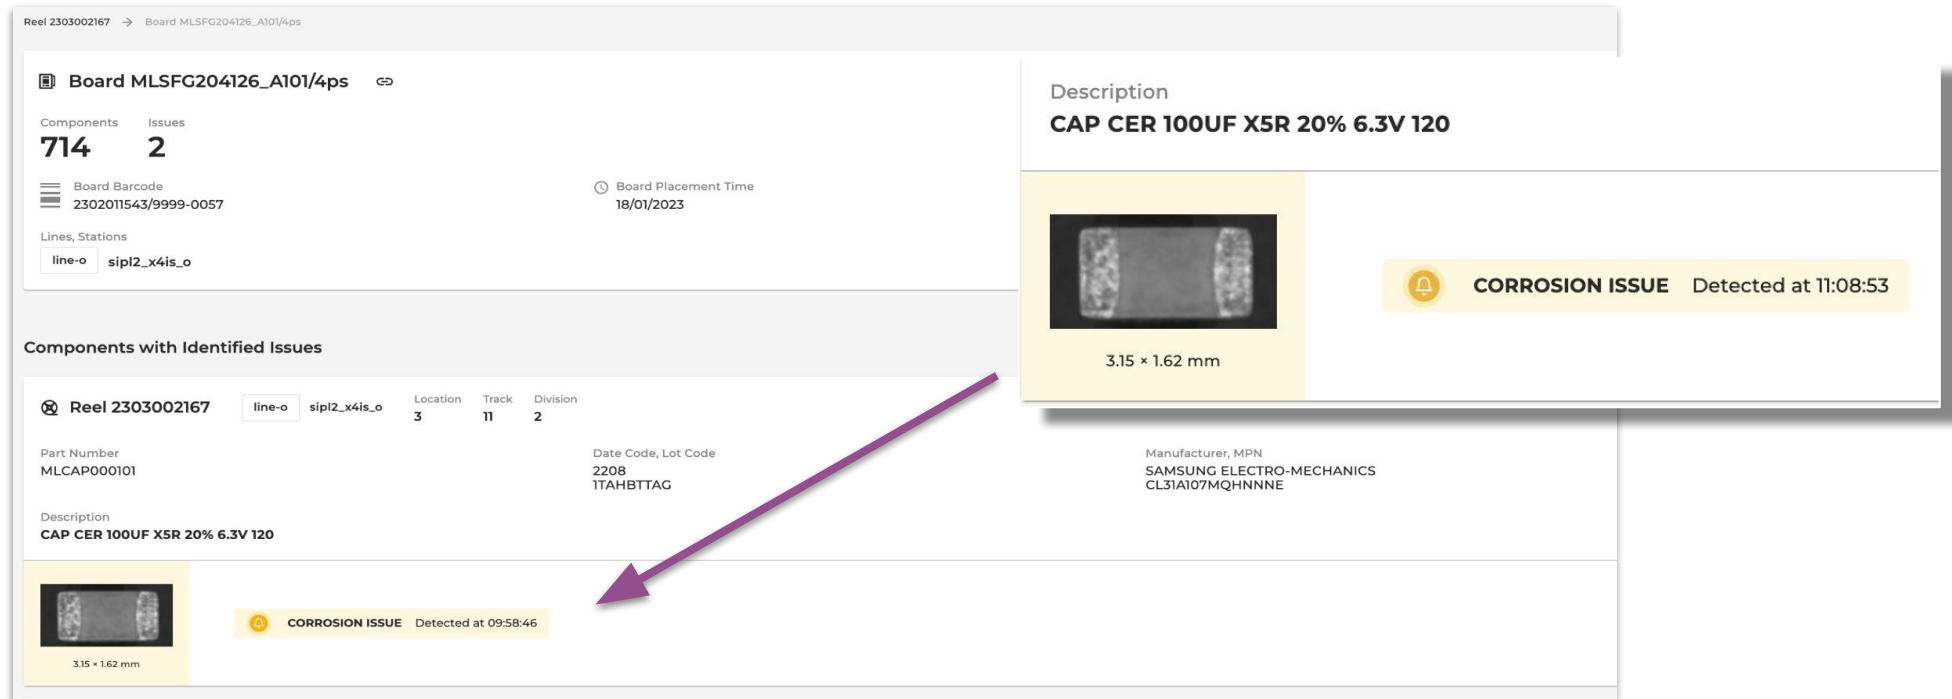
Board View

Each board analyzed including all components
During production the platform alert for boards with component issues

The screenshot displays the 'Board View' interface for a specific board. At the top, it shows the board ID 'Board MLSFG204126_A101/4ps' and a summary of 714 components and 2 issues. A 'Board Placement Time' of 18/01/2023 is also noted. The interface is divided into several sections:

- Board Information:** Includes 'Board Barcode' (2302011543/9999-0057) and 'Lines, Stations' (line-o: sip12_x4is_o).
- Component Details:** A large panel for a specific component with the description 'CAP CER 100UF X5R 20% 6.3V 120'. It features a microscopic image of the component, its dimensions (3.15 x 1.62 mm), and a yellow alert box indicating a 'CORROSION ISSUE' detected at 11:08:53. The manufacturer is listed as SAMSUNG ELECTRO-MECHANICS (MPN: CL31A107MQHNNNE).
- Components with Identified Issues:** A table listing components with issues. A purple arrow points from this table to the detailed view of the component above.

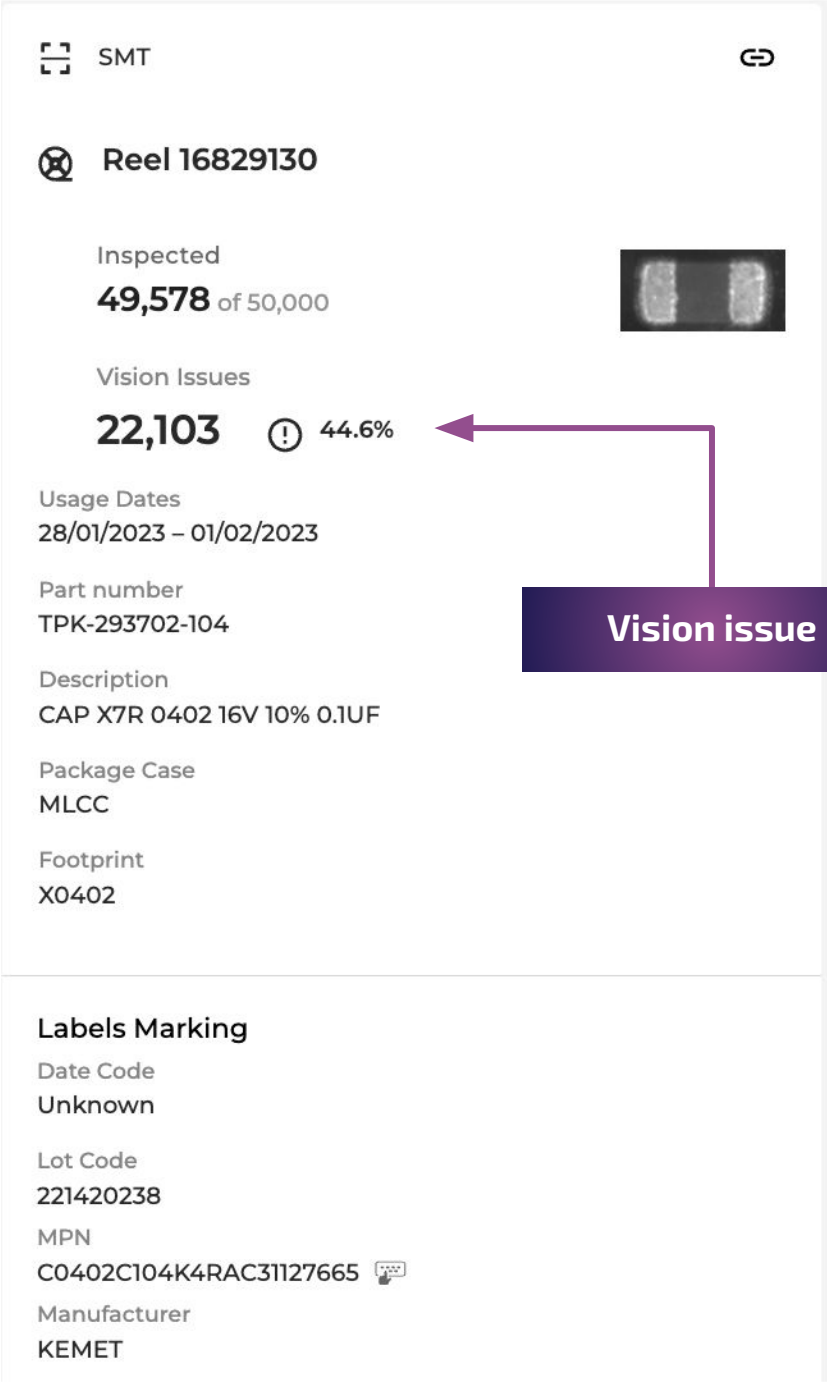
Machine Setup Issues

During production the platform alert on setup issues

Setup alerts includes vision issues, blurry images and bad pickups which allow the CM to fix issues in real time.

The screenshot displays a machine interface with the following information:

- SMT** (top right)
- Reel 16829130** (top left)
- Inspected 49,578 of 50,000** (middle left)
- Vision Issues 22,103 44.6%** (middle left, with a warning icon and a purple arrow pointing to a 'Vision issue' callout box)
- Usage Dates 28/01/2023 – 01/02/2023** (middle left)
- Part number TPK-293702-104** (middle left)
- Description CAP X7R 0402 16V 10% 0.1UF** (middle left)
- Package Case MLCC** (middle left)
- Footprint X0402** (middle left)
- Labels Marking** (bottom section)
 - Date Code: Unknown
 - Lot Code: 221420238
 - MPN: C0402C104K4RAC31127665
