DPA 2026

Presented By: Trevor Devaney

President, Hi-Rel Laboratories, Inc.®

Hi-Rel Laboratories
2025 DPA Results

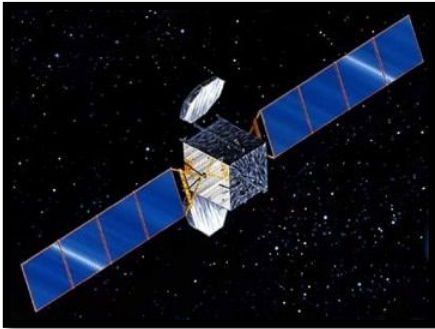
In 1996, several HS-601 Spacecraft failed on orbit due to their controller microprocessors being shorted out.

- Problem was isolated to the relays that controlled power to the processors
- Re-examination of the ground spares showed the hook lead terminals and bodies were pure Sn plated
- Previous research by the same manufacturer revealed Sn whiskers formed on these hooks when placed in a vacuum, creating a self sustaining arc permanently latching the relay
- On orbit the result was catastrophic!

Photo From ISTFA 1992
Proceedings.
"Tin Whisker Induced Failure
in a Vacuum"
Authors: D.H. Van
Westerhuyzen, P.G. Backes,
S.C. Merrel, and R.L. Poeschel
- All with Hughes Aircraft.

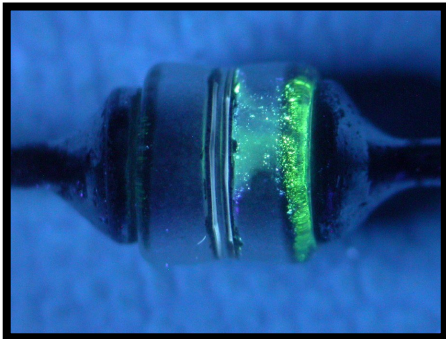
DEVICES WITH HERMETICITY
ISSUES.

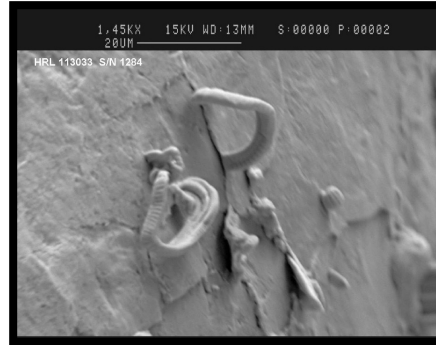
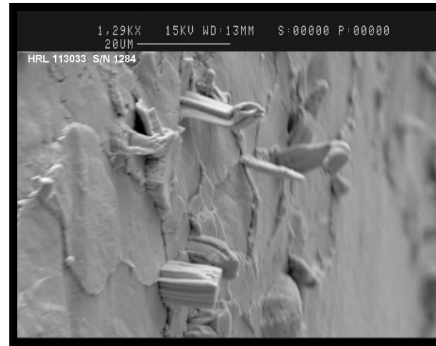
PURE TIN PLATED CAPACITOR END METALLIZATION.
NOTHING TO WORRY ABOUT, RIGHT?

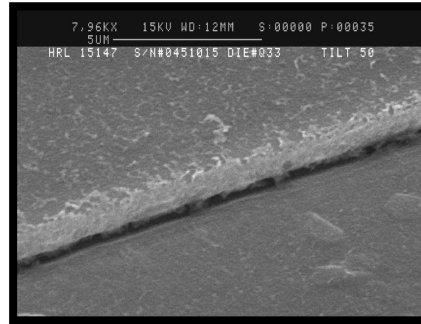
METALLIZATION STEP COVERAGE IN A TRANSISTOR WITHIN A DC-DC-CONVERTER HYBRID.

CAUGHT AT FINAL DPA OF A HYBRID. WHAT HAPPENED TO WLAT?

COLLECTOR STEP OF TRANSISTOR. NOTE 2% METAL COVERAGE.

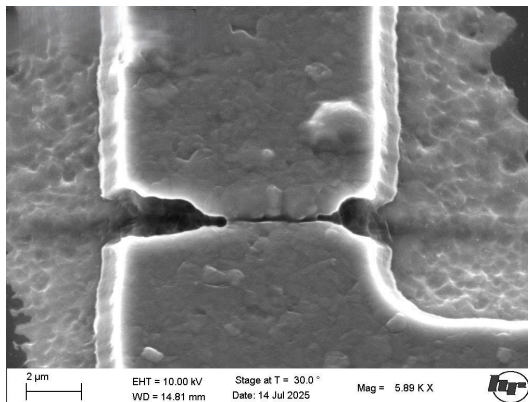
Step Coverage

Old designs produce old defects! Classic tunneling of the metallization due to wet chemical metal etching during fabrication..

1970's tech but still used.
