Overview of the Failure Analysis Process and Common Failure Mechanisms in Various Electronic Components

Hi-Rel Laboratories, Inc.

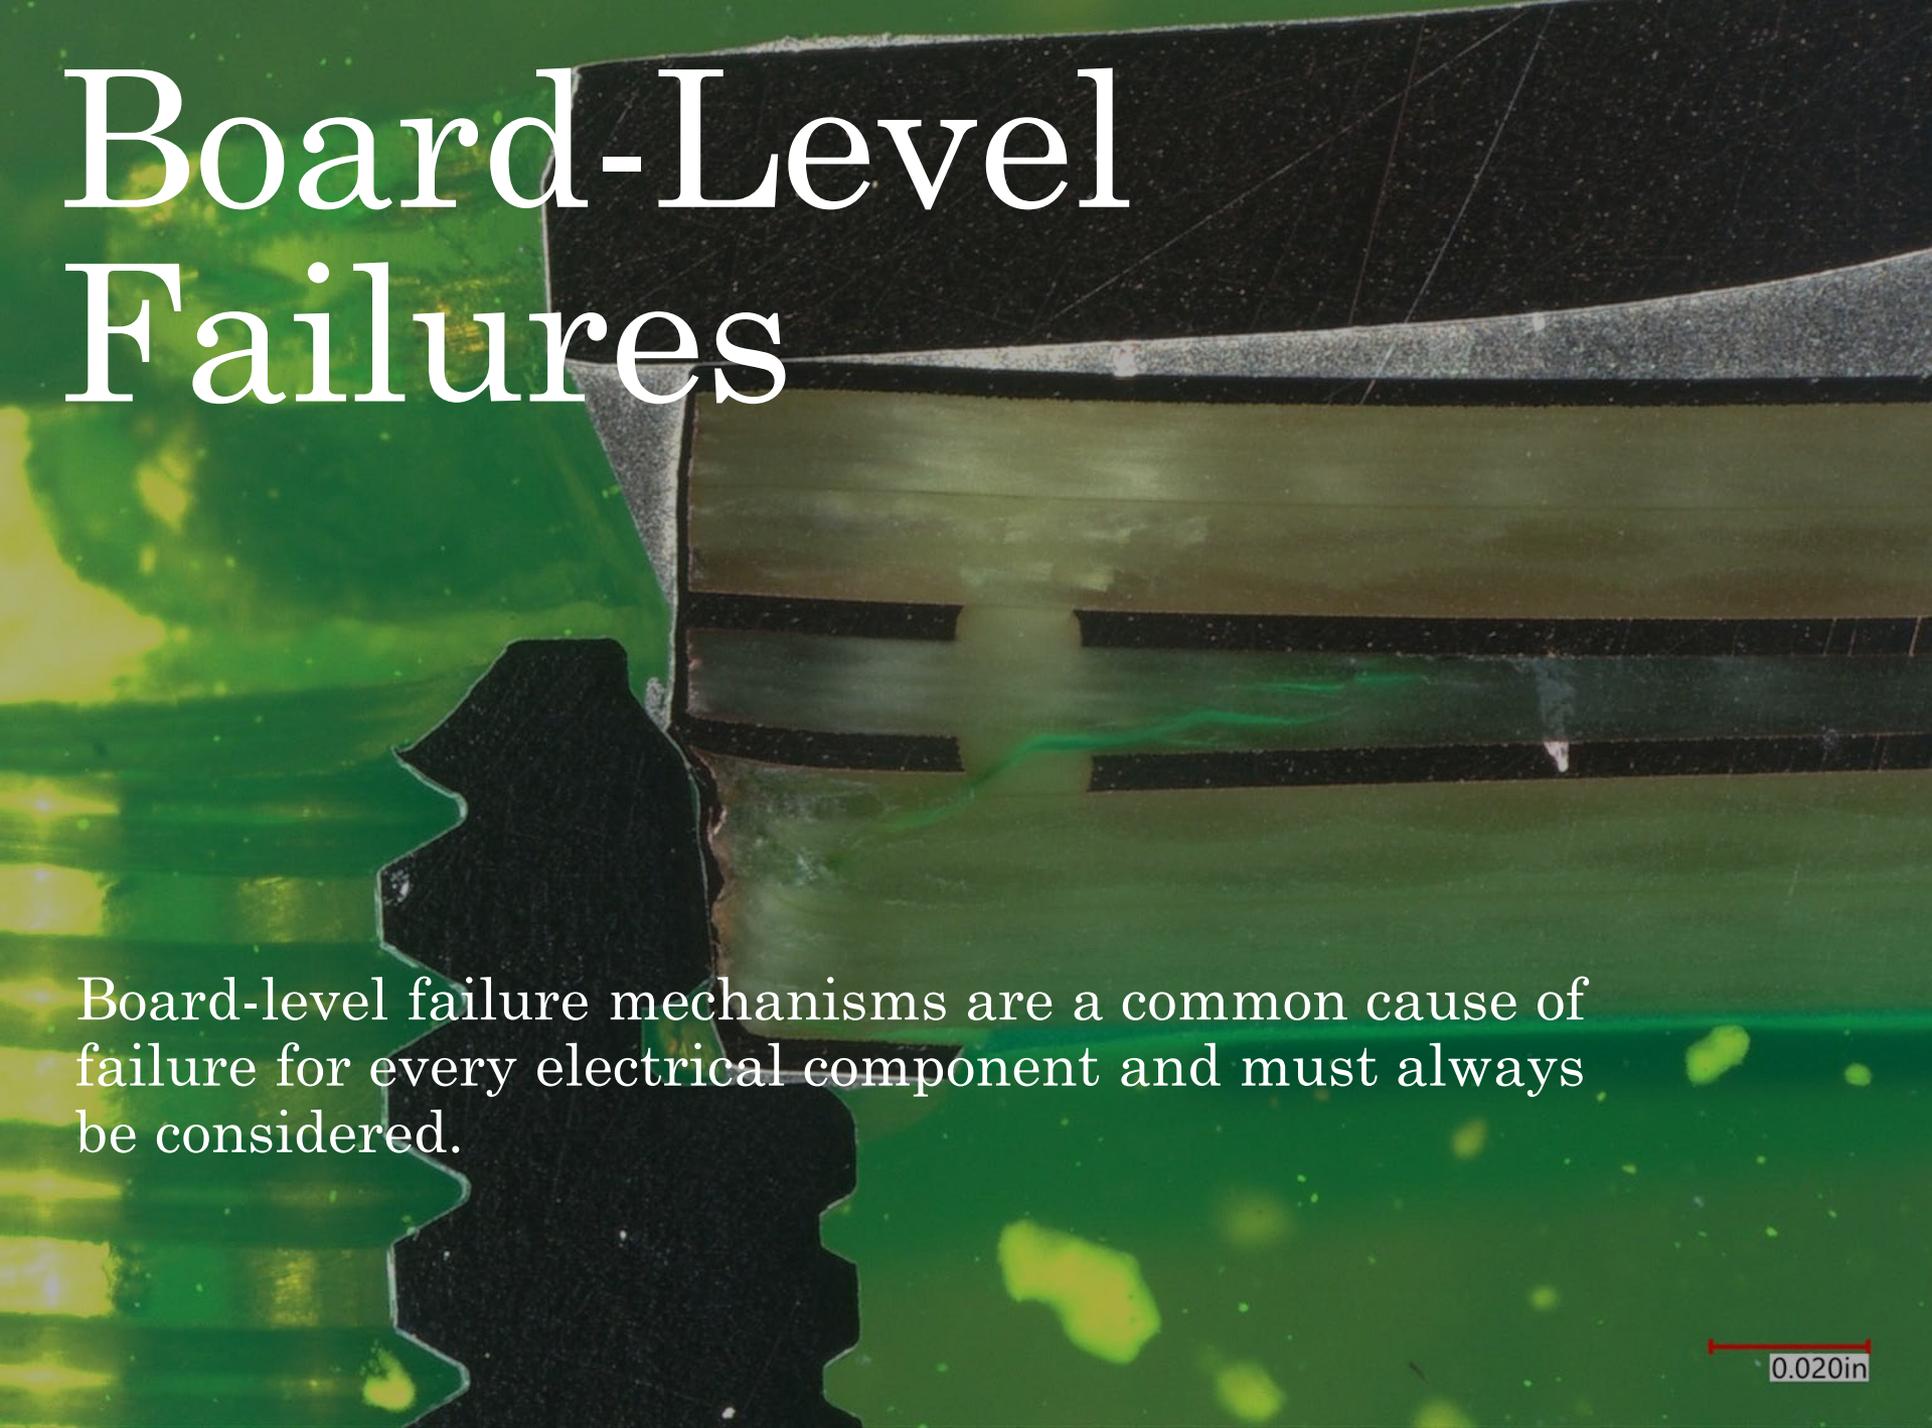
A microscopic image showing a cross-section of a board-level failure. The image displays a dark, jagged fracture surface on the left, with a greenish-yellow background. The fracture surface is irregular and shows signs of mechanical failure. The background has a mottled appearance with some horizontal lines and a dark, curved structure at the top.

Board-level failure mechanisms are a common cause of failure for every electrical component and must always be considered.

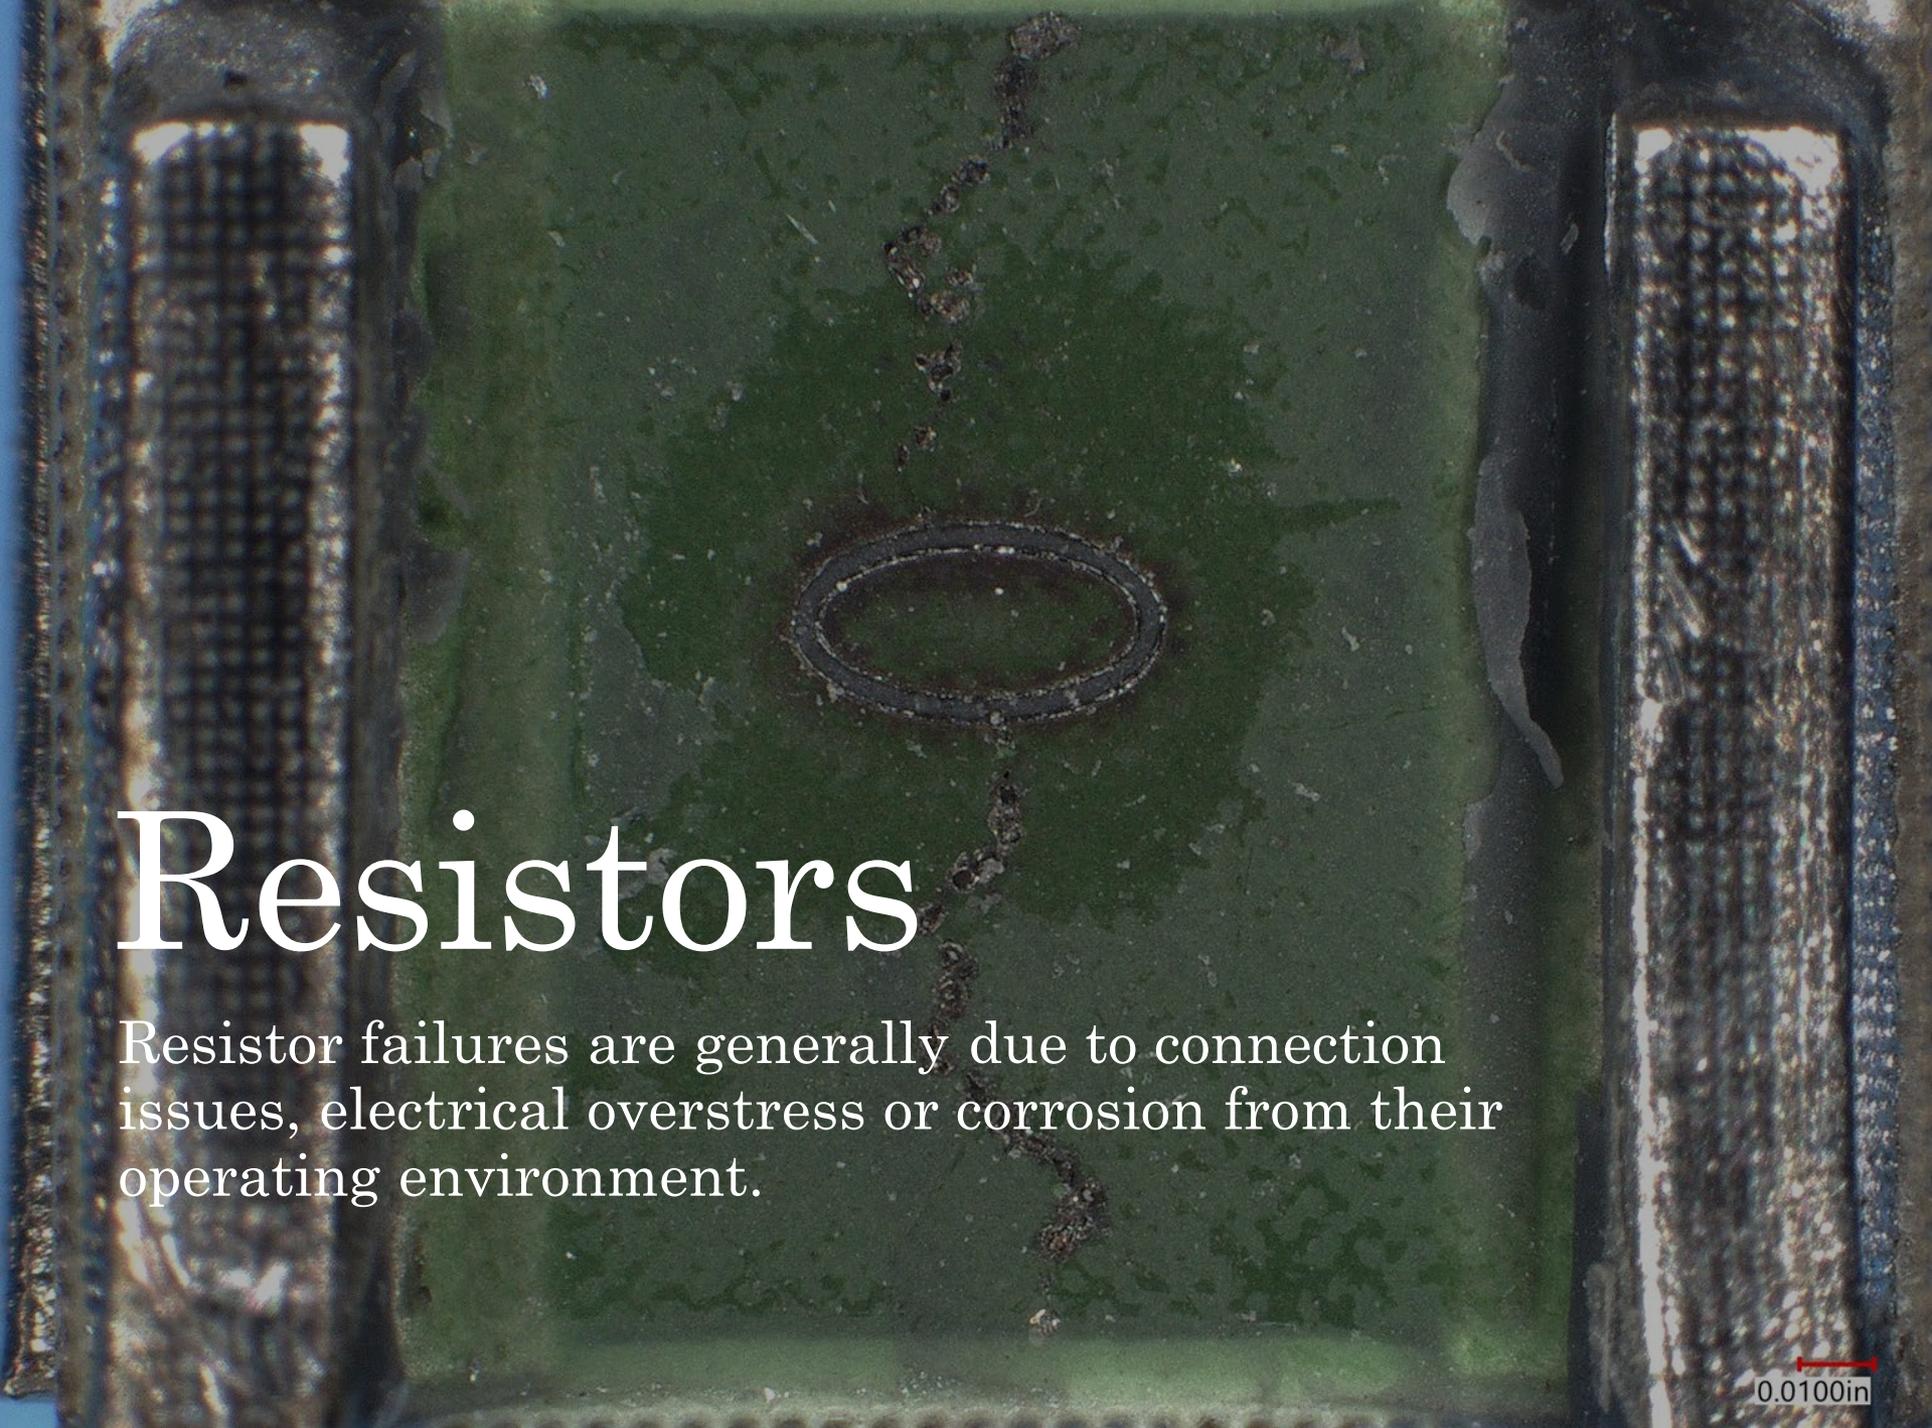
A microscopic view of a resistor failure on a green PCB. The resistor is a rectangular component with a grid-like pattern. A circular crater is visible in the center of the resistor, indicating a failure. The surrounding PCB material is green and shows some signs of corrosion or damage. A scale bar in the bottom right corner indicates a length of 0.0100 inches.

Resistor failures are generally due to connection issues, electrical overstress or corrosion from their operating environment.

- Corrosion
 - Corrosion is a common failure mechanism for every style of resistor.
 - Can affect resistor element or interconnect metallization.
 - Generally attributed to packaging/seal issues.
 - Can be due to moisture or ionic contamination

- Electrical Overstress
 - Electrical overstress is a broad term, but typically refers to failure due to excessive current or high voltage conditions.
 - The location of the failure within the device, the severity of the damage, and associated circuitry can determine more specific information related to the failure

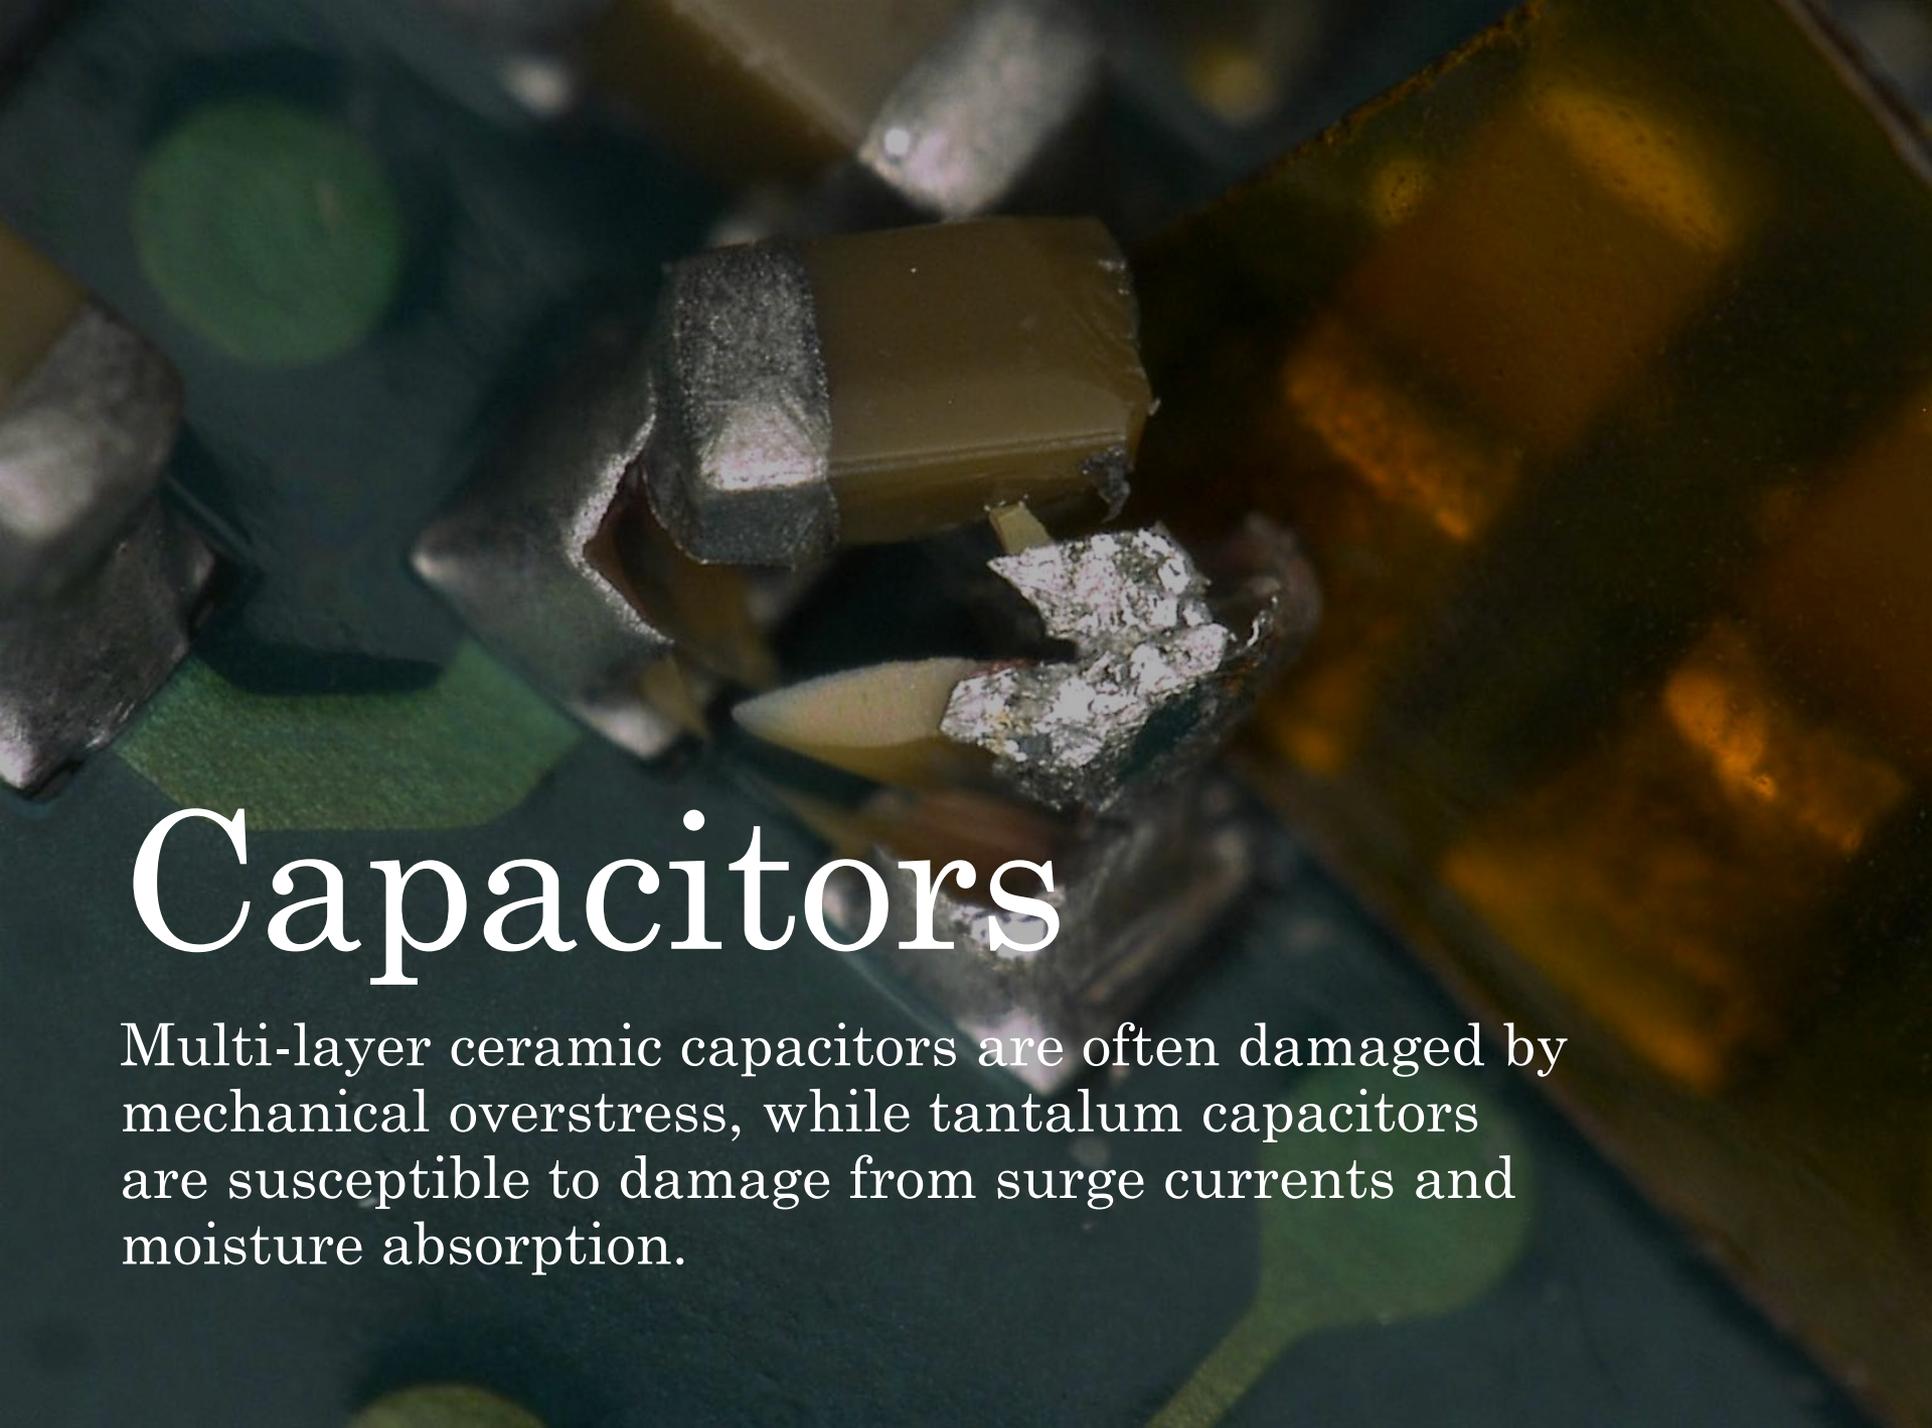
A microscopic view of a capacitor, likely a multi-layer ceramic capacitor, showing significant damage. The capacitor is cylindrical and has a dark, possibly metallic, coating. The top surface is severely cracked and fragmented, revealing a light-colored, porous internal structure. The background is dark and out of focus, showing other components and a green circular feature.

Multi-layer ceramic capacitors are often damaged by mechanical overstress, while tantalum capacitors are susceptible to damage from surge currents and moisture absorption.

- Mechanical overstress
 - By far the most common failure mechanism for multi-layer ceramic capacitors.
 - Can begin as benign microfractures that propagate with time/temp/stresses, subsequently resulting in current leakage or short circuiting.
 - Flexure cracks have characteristic “45 degree” fracture spanning from the tip of the end metal towards the termination.

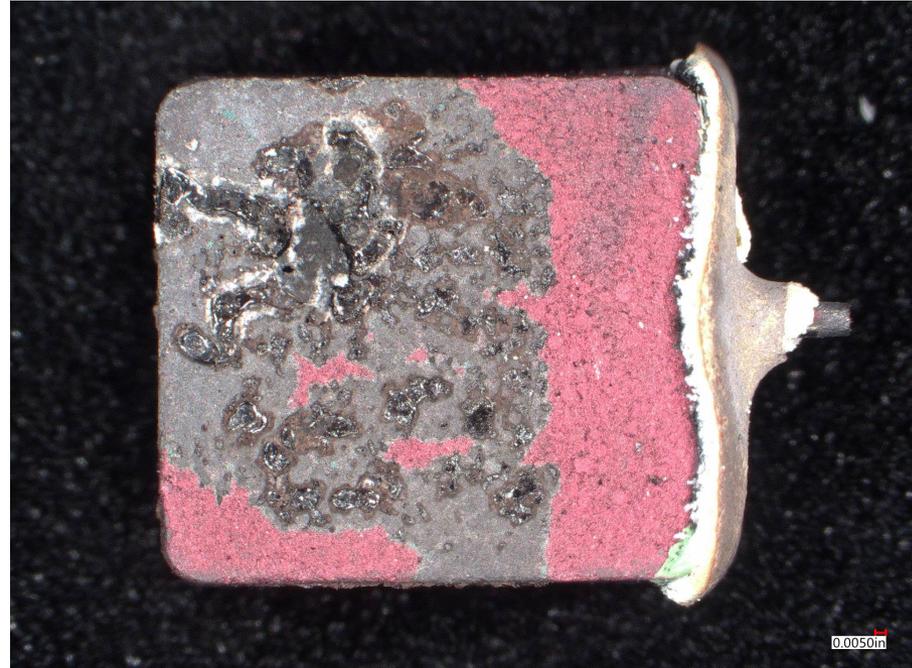
- EOS/Surge current and ESR considerations
 - Tantalum capacitors are commonly damaged by high in-rush current (i.e. surge current).
 - This type of failure can be due to equivalent series resistance (ESR) variations in tantalum capacitor banks.

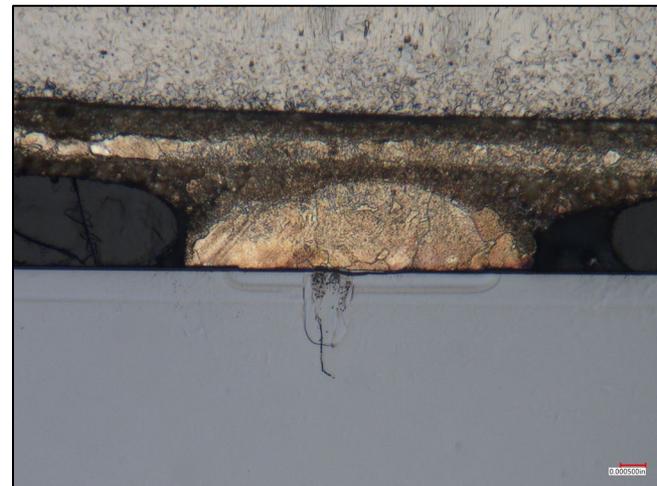
- Electrical overstress (EOS)
 - EOS is typically due to high reverse voltage, high forward current, or a high speed voltage transient.
 - Electrostatic discharge (ESD) damage is similar in appearance to reverse-biased high-speed voltage transients, and generally occur at the edge of the anode contact area (upper image), while forward biased current transients occur central to the die where current density is the highest (lower image).

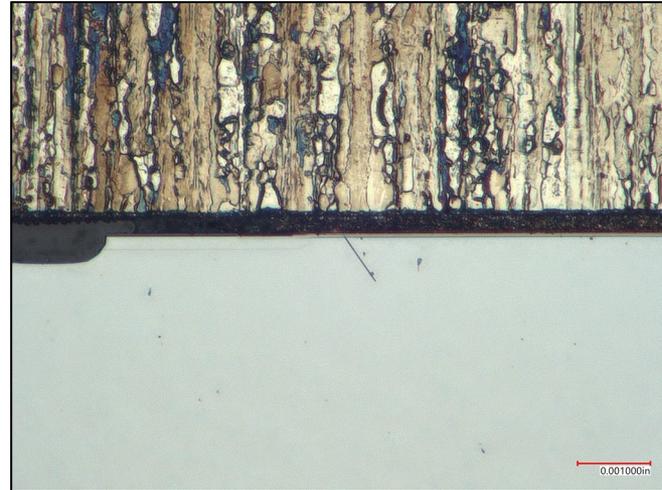
- Thermal/Mechanical overstress
 - Glass body diodes are susceptible to fracturing due to lead forming, handling, and thermal overstress induced during the soldering process.
 - These fractures can result in low level leakage, with the potential to worsen over time and temperature.

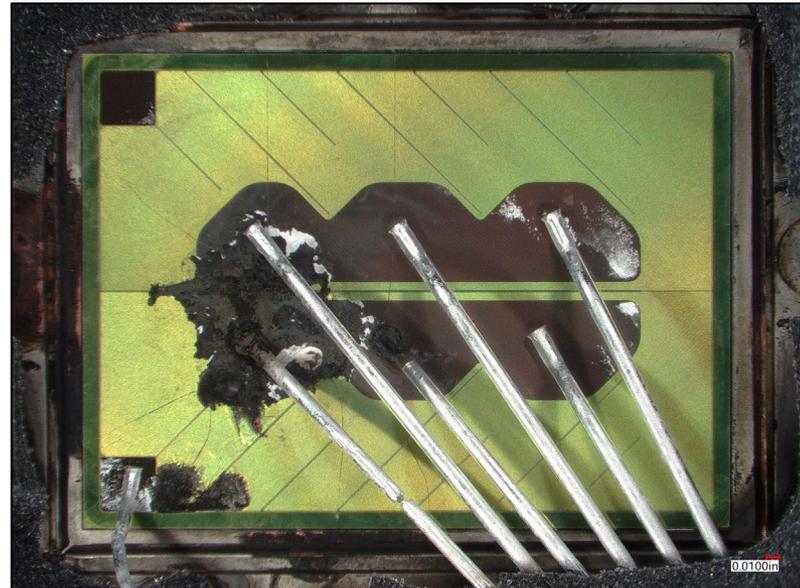
- Electrical overstress
 - Failure due to excessive power dissipation can be the result of several initiators and can be difficult to determine the true cause. Common mechanisms can include:
 - High on-state current in excess of the specified rating
 - Inadequate heat sinking of power-devices
 - Linear-mode operation/operation outside of the specified SOA
 - Can be due to an open circuited gate or insufficient gate drive.
 - The damage is obvious and can sometimes be detected during radiographic inspection.
 - The resistance of the short circuit is often very low; $<1\Omega$.

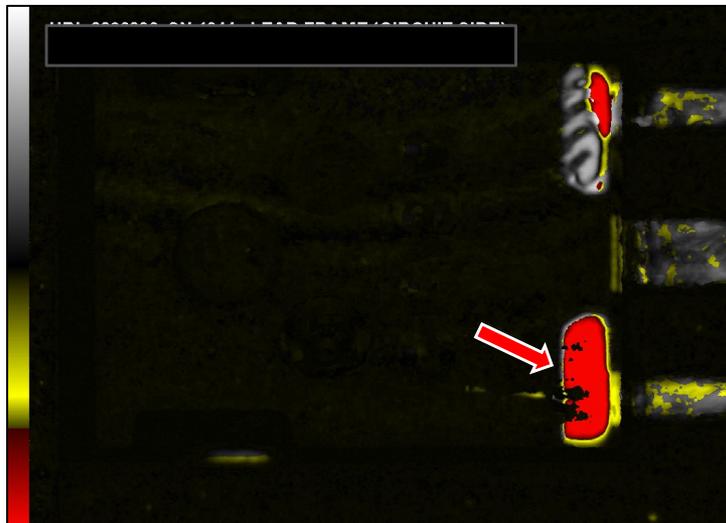
- Open gate – delaminations
 - In FETs, an open circuit at the gate results in a floating gate condition, which generally leads to the destruction of the transistor as it operates in the linear mode.
 - This can occur due to any failure in the gate drive circuit, but is also observed in the transistor itself when lead-frame delamination occurs, pulling the more fragile gate wire from the lead.
 - Scanning acoustic microscopy can identify lead-frame delamination, but beware of water ingress which can result in “false negatives”.

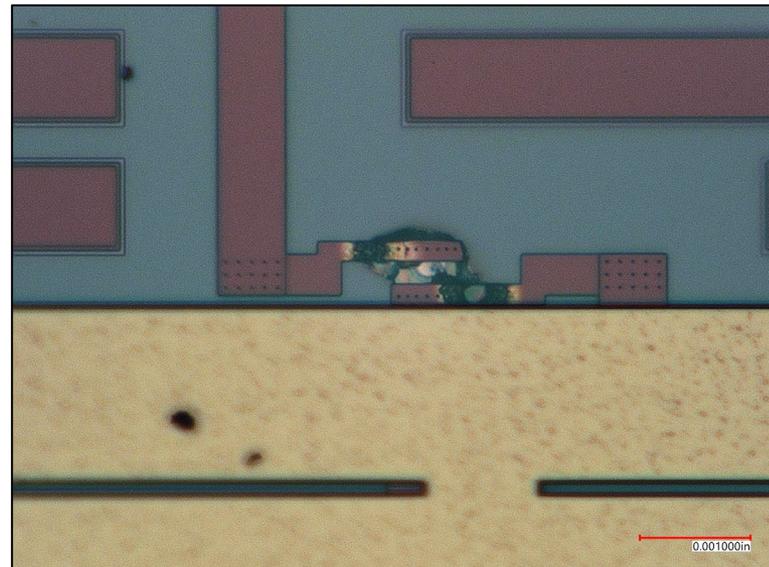
In the image to the right, EOS was identified as the cause of failure. The failure was the result of high current, less than the fusing current of the 1mil gold wire, $\sim 1.5A$. No evidence of arcing or breakdown was discovered, indicating the failure was strictly due to a high current condition.

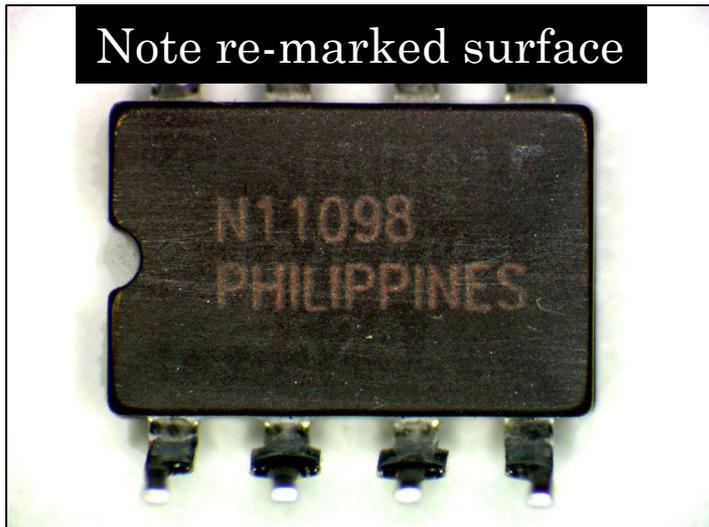
- Counterfeit components have been a problem in the electronics industry for many years. With recent supply chain shortages, some companies have been forced to procure components from less reliable sources.
- Counterfeit detection is performed by comparing the construction of each aspect of a device to a known good sample.
 - This includes part markings, dimensions, lead frame structure, test data, die layout and markings, etc.
