ESA recent challenges in space missions: Cracked capacitors time bomb & Forbidden solderless connectors

Copernicus Sentinel S1B: The Failure

Copernicus Sentinel S1B: The Root Cause

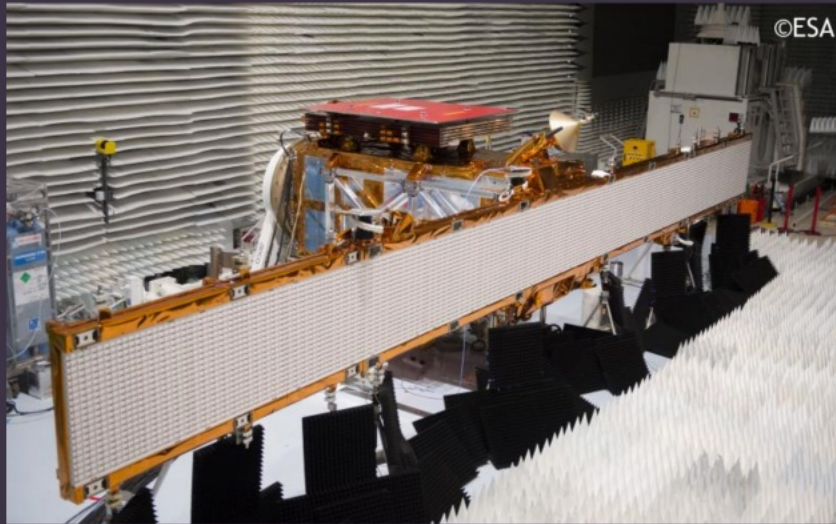
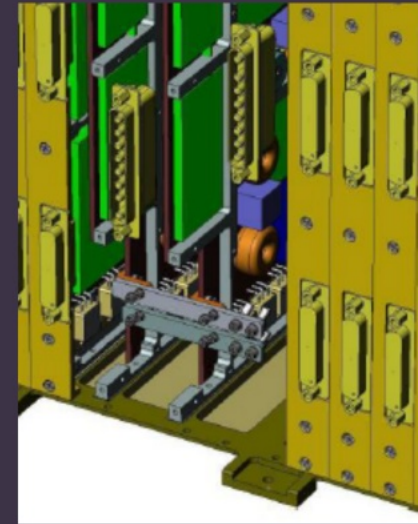
Sentinel-1B synthetic aperture radar (SAR) payload has malfunctioned and has ended the spacecraft's mission more than six years after its launch!

It was discovered that the main problem is related to the 28V regulated bus of the CAPS (C-SAR Antenna Power Supply), as it was observed that the main & redundant 28V power regulators were both unexpectedly OFF.

The CAPS is the unit –part of the electrical power sub-system of the platform –that provides power to SAR elements, including the SAR electronics.

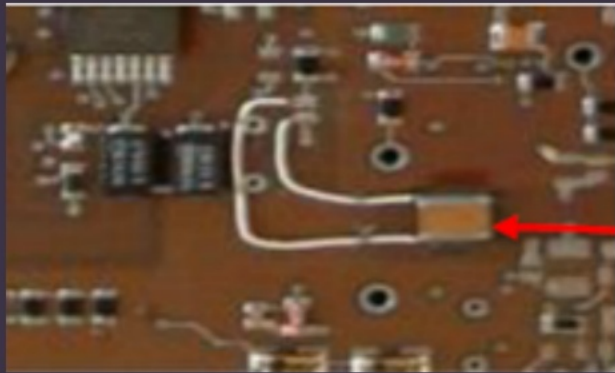
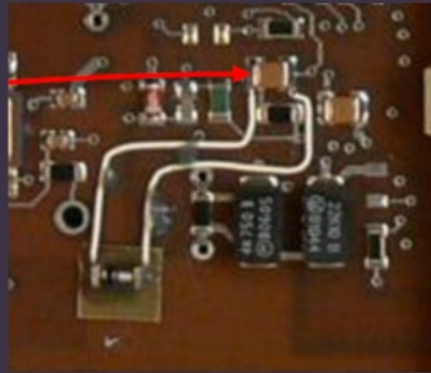
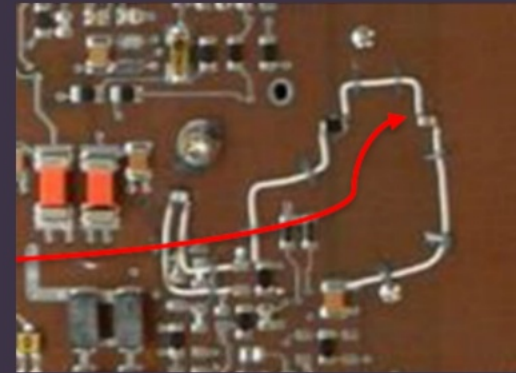
The possible Root cause is the rework (direct wiring) of ceramic (Type II) capacitors!

This capacitors had to be replaced as a result of a non-compliance detected during the manufacturing and testing phase. For the repair, the capacitors were soldered using a direct wiring soldering process.

At the time of this rework, direct wiring on the capacitor was fulfilling applicable product assurance requirements. This repair process is no longer authorized following revision of applicable ECSS standard in 2017:

Since 2019, Memo ESA-TECQTM-MO-1143 also forbids direct wiring of ceramic capacitors type II and recommends the use of dedicated patch boards.

Wiring directly on the component termination (eg. Component bonded on PCB and wiring connection made) and wiring made on the same PCB pad than the capacitor (modification after component assembly) shall not be performed due to possible damage within the component such as crack in the ceramic.

It is recommended either to use a patch board with separate pads for the wiring (for addition of a capacitor) or to replace the capacitor during the wiring (modification applied after assembly)

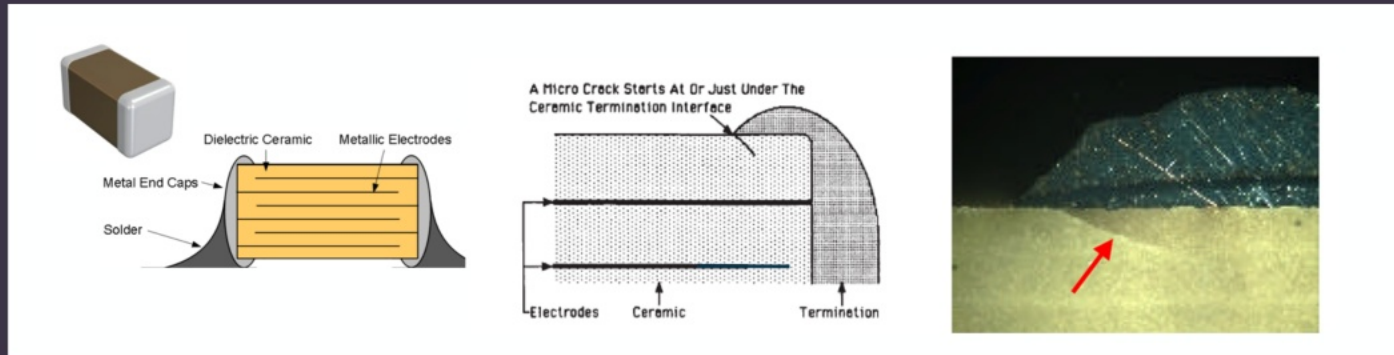
During direct soldering of wire on chip ceramic capacitors, heat distortion occurs inside the chip capacitor.

A crack occur: It starts at the weakest point at the interface between the ceramic and the end point of the termination.

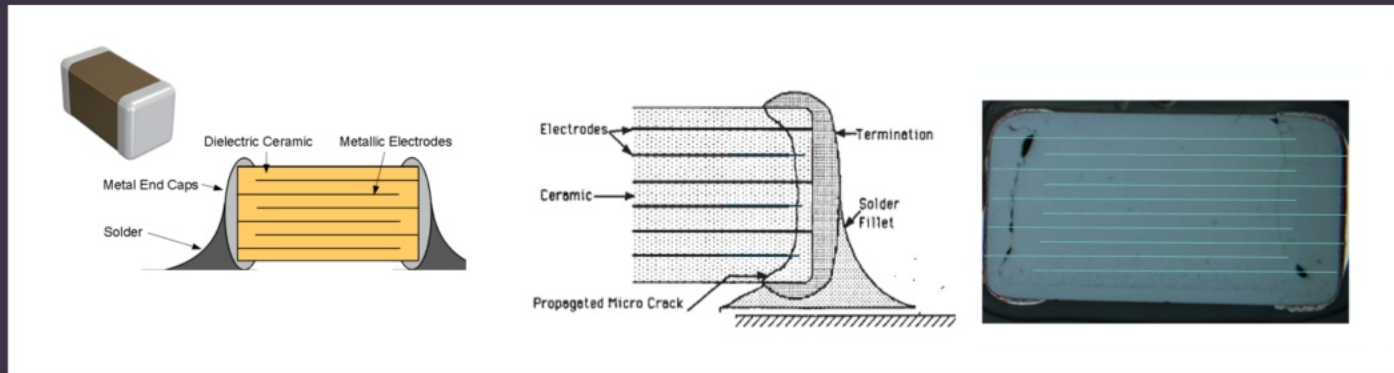
After several thermal cycles, the thermal shock crack propagates:

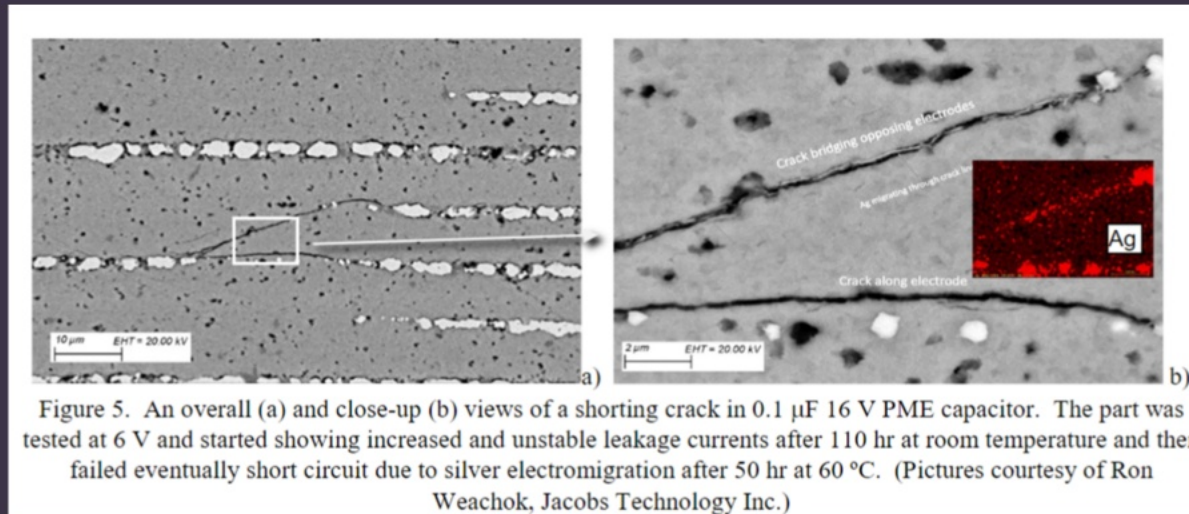
Diffusion and migration of Ag into dielectric layers from inner Ag or Ag/Pd electrodes might pose a problem for long-term reliability.

Silver is a material that is most susceptible to electromigration in the presence of moisture, and for this reason, cracking of PME (Precious Metal Electrode) capacitors creates a high risk of electrical failures.

This results to excessive current leakage.

As the leakage current gradually increases, the heat generated by the capacitor continues to increase, which will eventually lead to dielectric thermal breakdown failure and a **short circuit**.

Cracks were generated during the direct wiring soldering on the capacitors. Silver Electromigration has then caused a Short-Circuit.

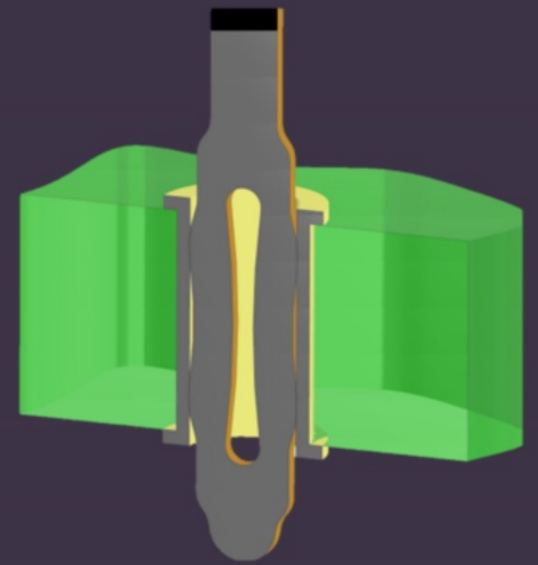
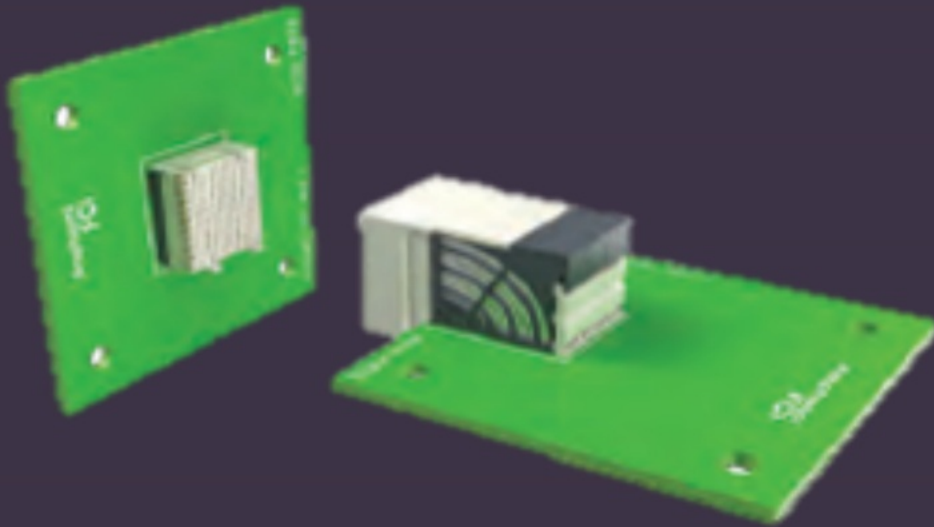
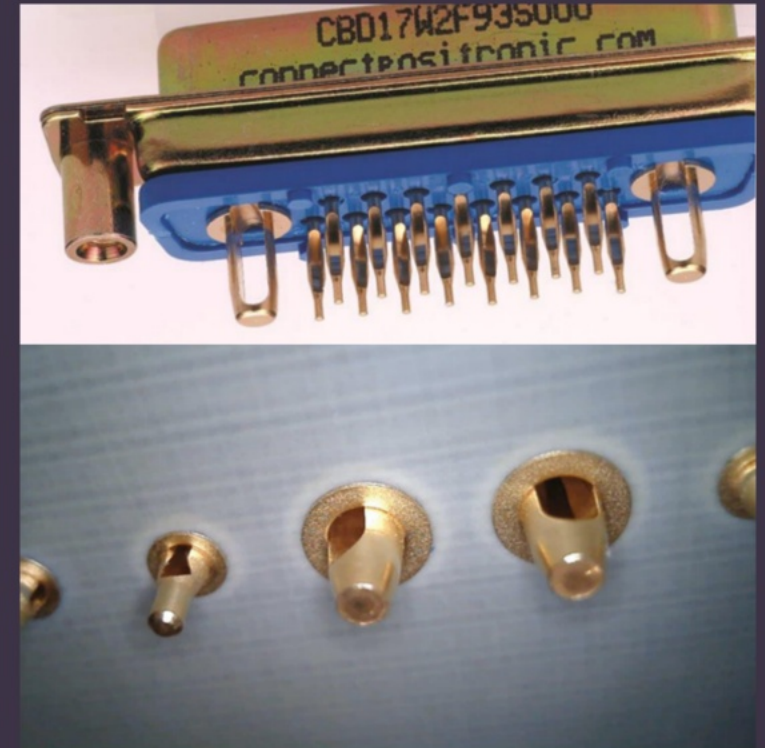
- 1.- Impedance discontinuities during mechanical tests**

All the mechanical stress goes through the press-fit terminations.
This leads to intermittent loss of connectivity during vibration or shock.

No clamping mechanism (or additional screws) to hold the mated pair together.

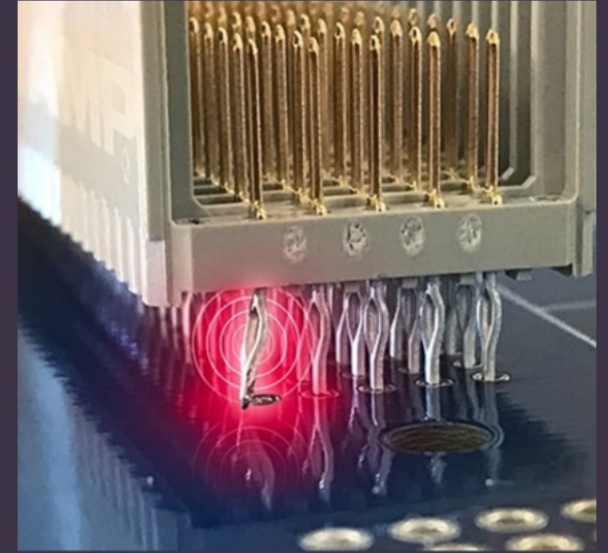
- 2.- PCB Damage due to fretting of the plating materials**

corrosion wear or cracks in PCB and pin materials, due to the relative movement of the press-fit pins inside the PCB.

- 3.- Growth of dendrites**

tin whiskers on pins with pure tin are also considered as delayed failures

This leads to an increase in contact resistance, thus a drastic decrease of the data rate!

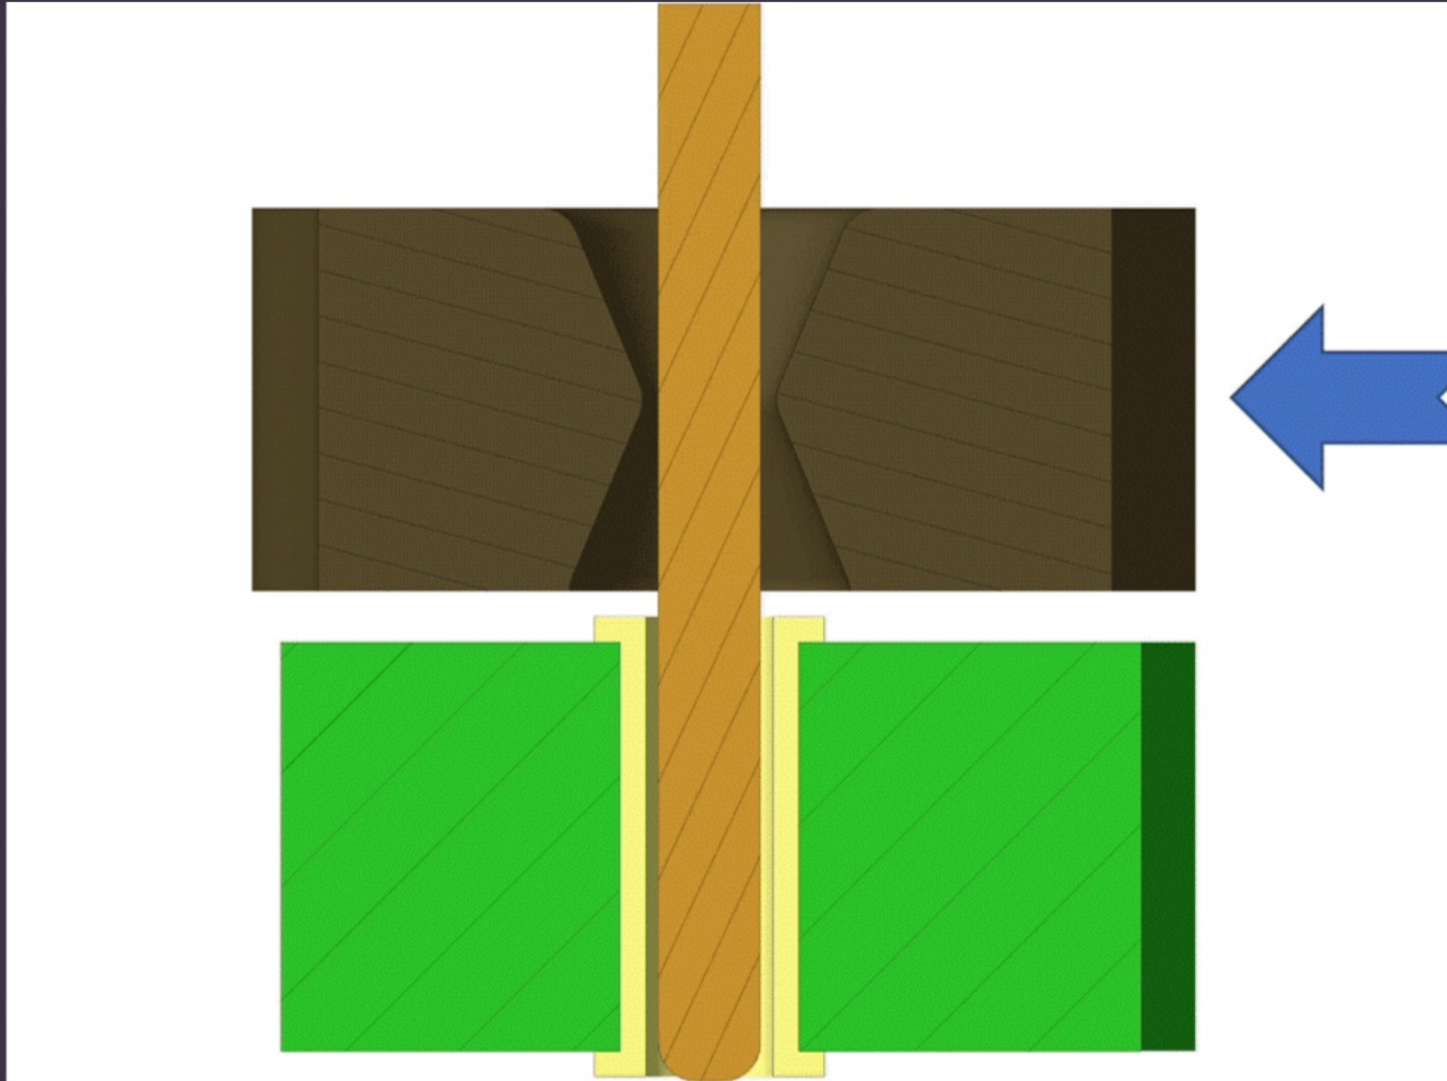
SLIDE-**F**IT
ELECTRICAL
CONTACT
TERMINATION

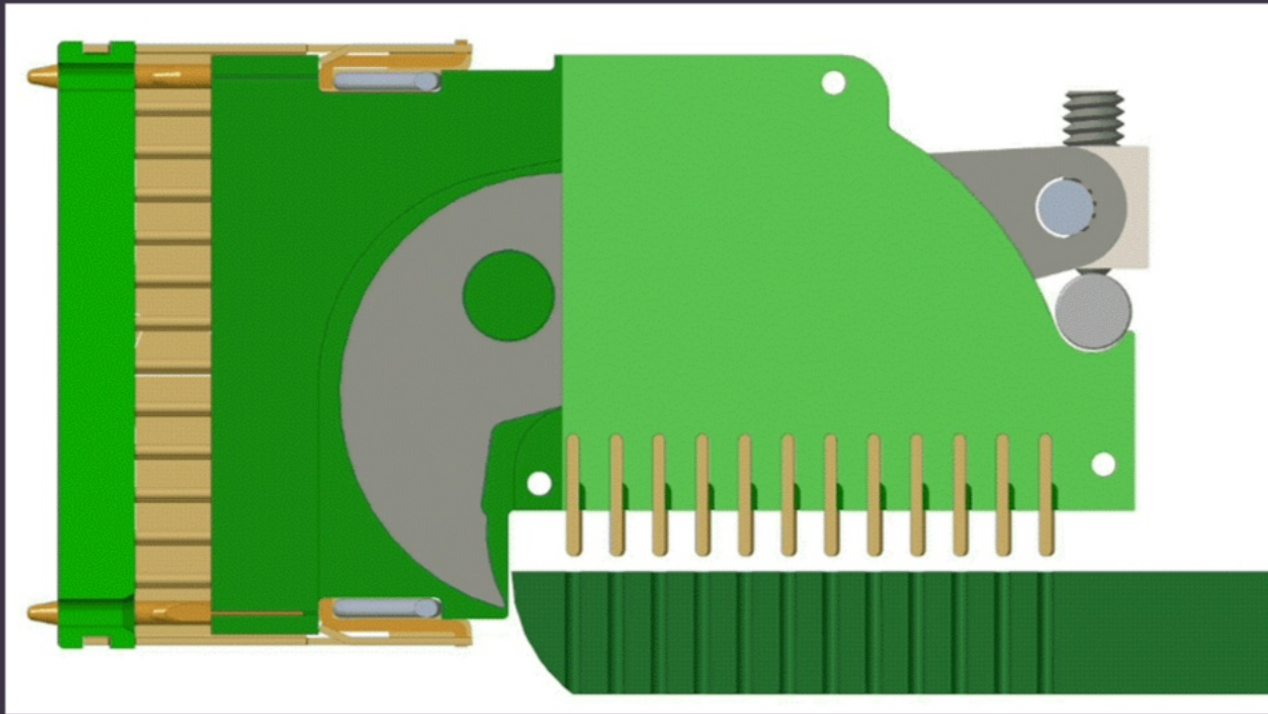
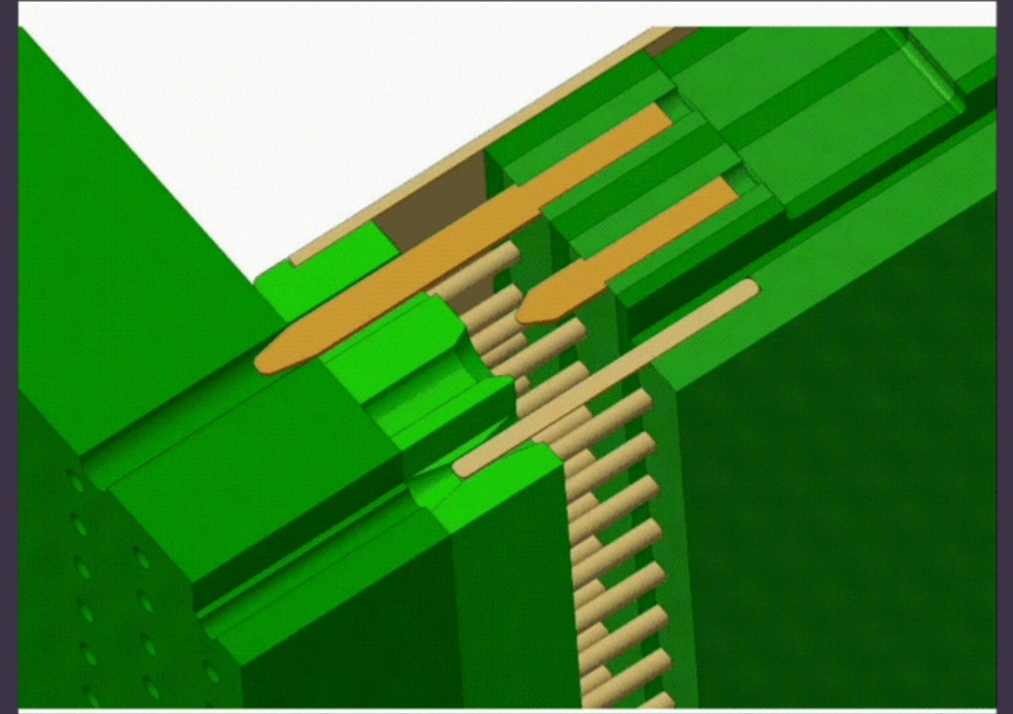
A Single-piece connector which blind-mates directly with the backplane!

The mechanical function is fully separated from the electrical function

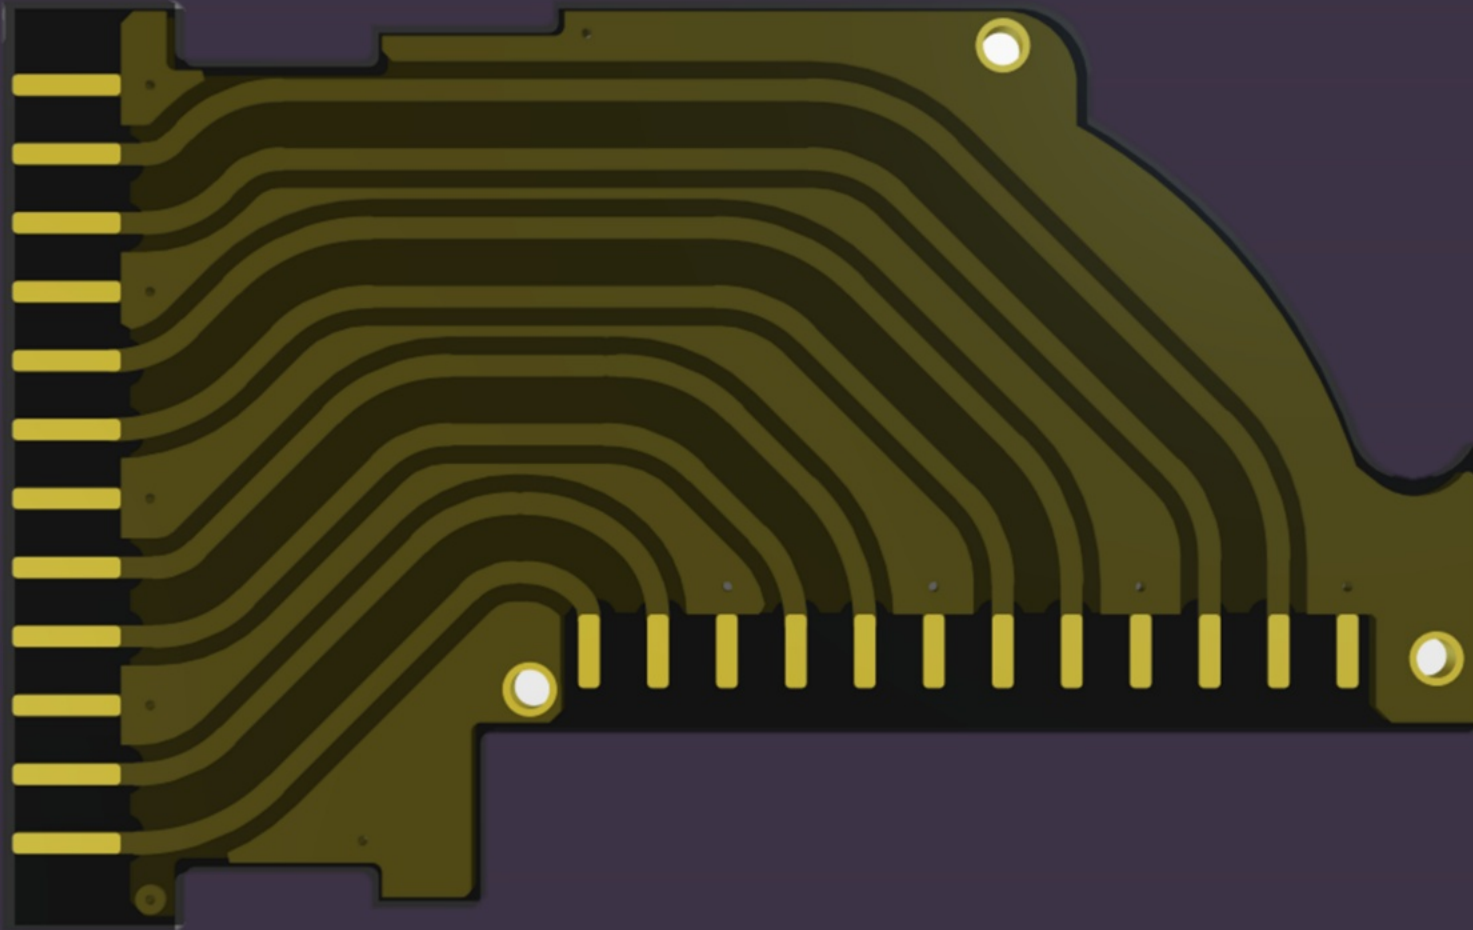
Eliminates the discontinuity between the internal tracks of the connector.

Based on “Tachyon 100G” material of internal PCB, given for high speed up to 100Gb/s.

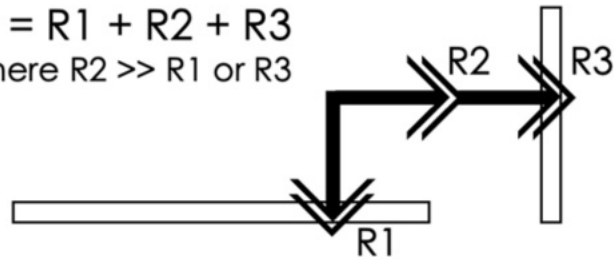
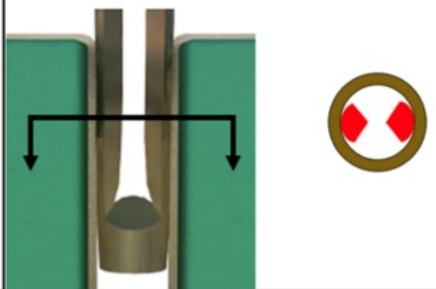
Requires special assembly tooling	Total resistance PCB to PCB: $R_t = R_1 + R_2 + R_3$ where $R_2 \gg R_1$ or R_3

Increased current density in reduced cross-section:

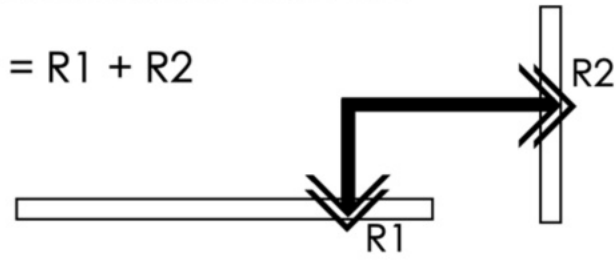
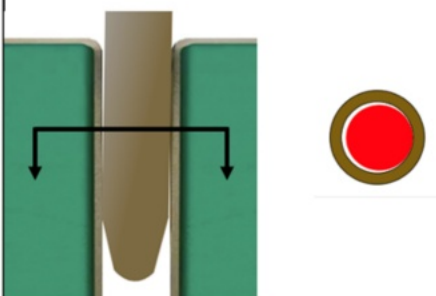
No special assembly tooling required	Total resistance PCB to PCB: $R_t = R_1 + R_2$

Same logic applies to impedance	Constant current density in continuous cross-section:
